Mercedes Comand Controller Rotary Wheel Scroll Knob Switch Button Unit Shaft Repair Fix Kit Install Instructions Guide Latest

by x8rltd

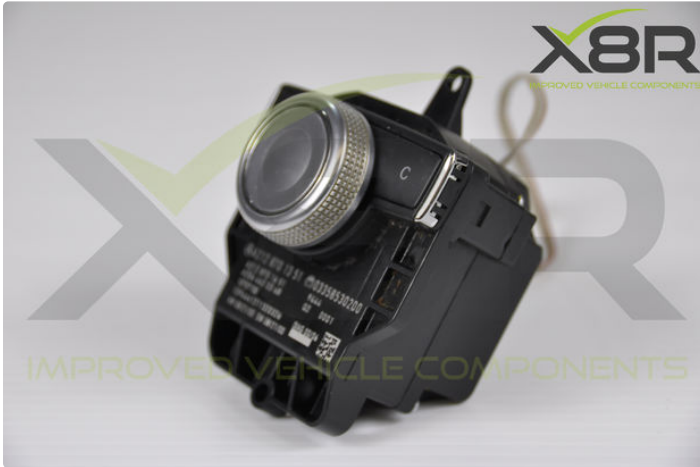
You may also need plastic pry tools, depending on how tough it is to separate the unit.

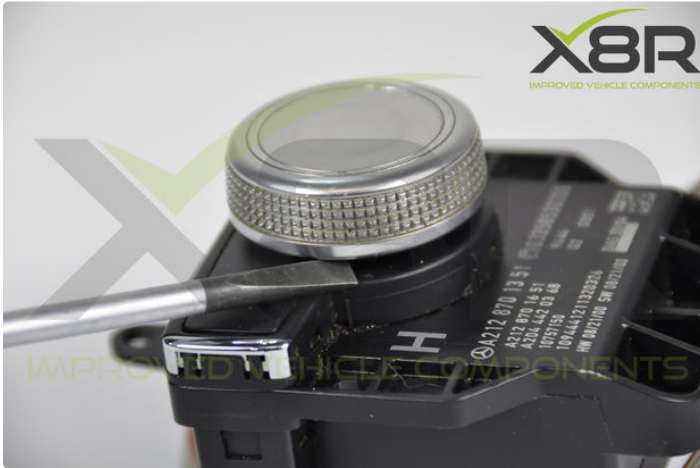
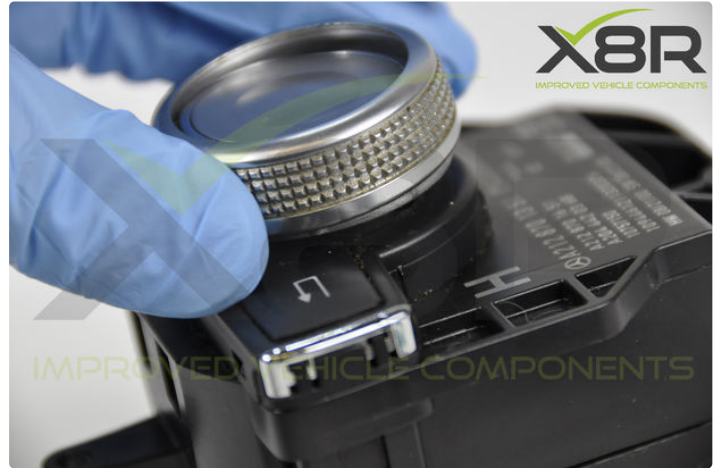
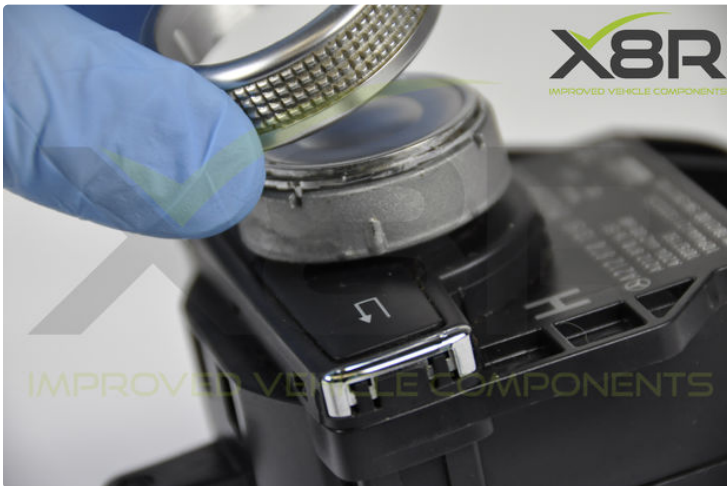
Step 2: Remove the Top Ring and Top Button Cover

Using the small flat headed screwdriver or a pick tool, gently lever the top ring away from the base.

Once this is away, you can gently lever the top button cover away using either the flat head screwdriver or a small plastic pry tool.

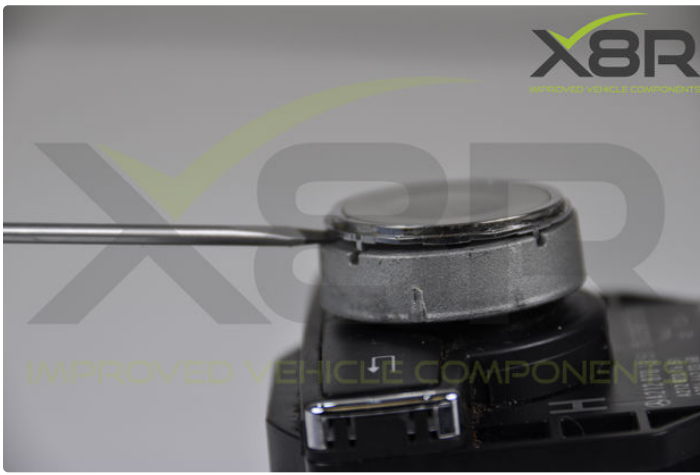
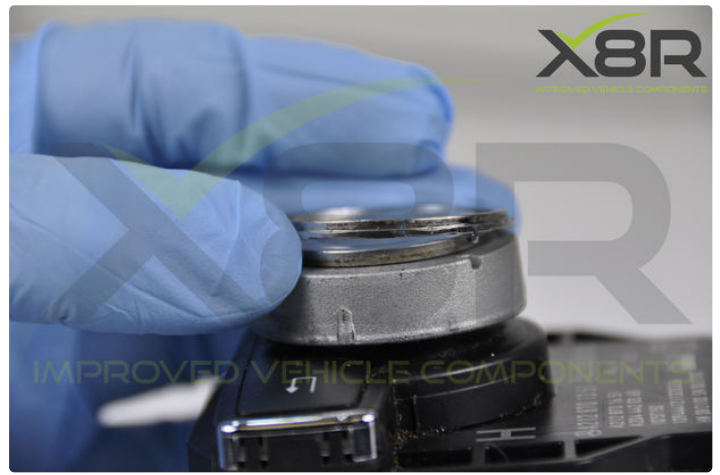
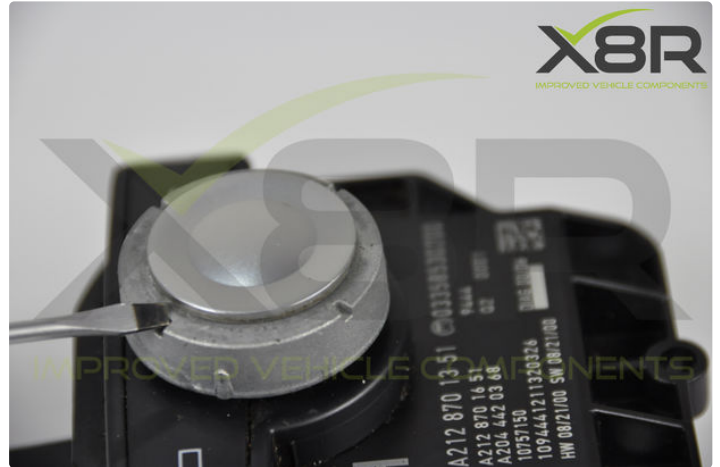
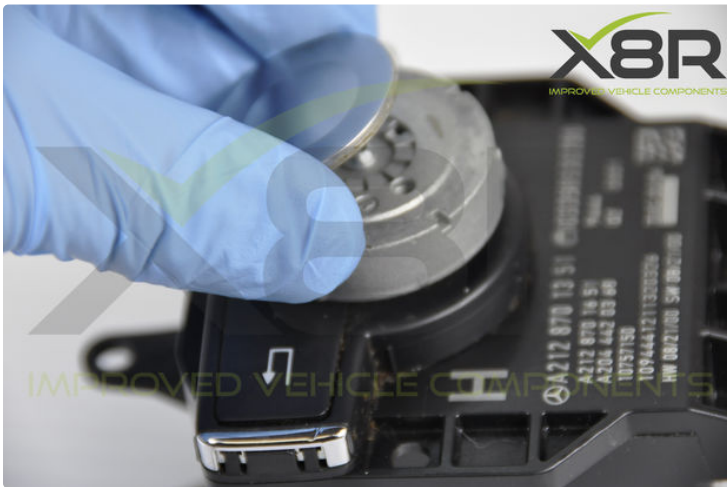
Step 3: Remove the Scrolling Dial

Use a T7 torx head screwdriver to remove the central screw (may vary by model). You will need to apply pressure downwards on the dial and then unscrew for it to come away.

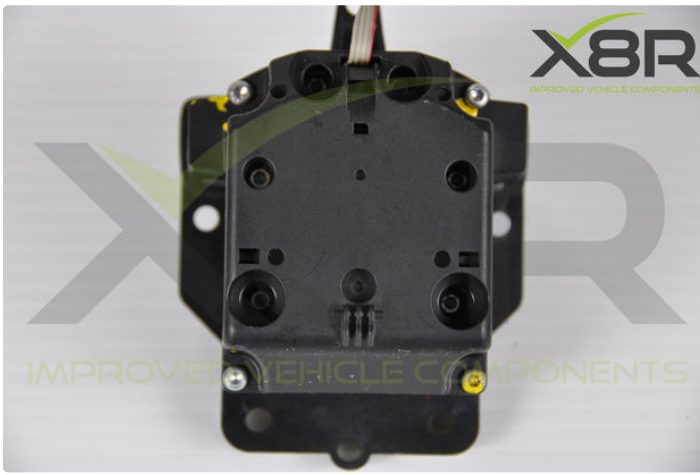
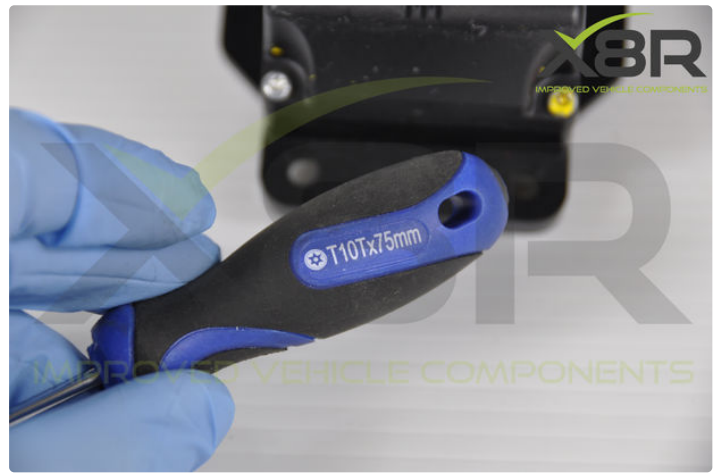
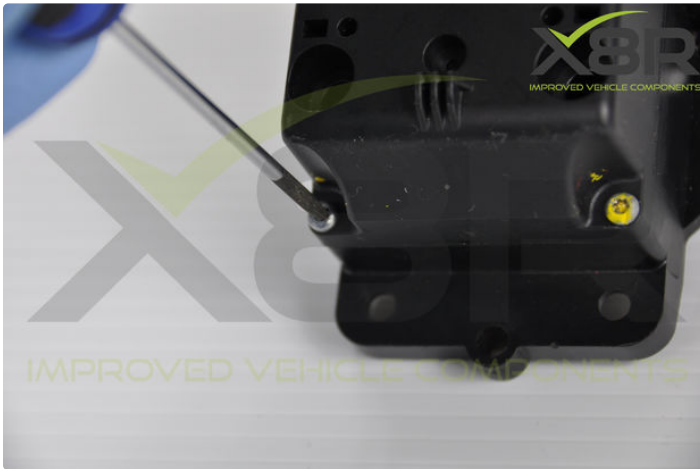
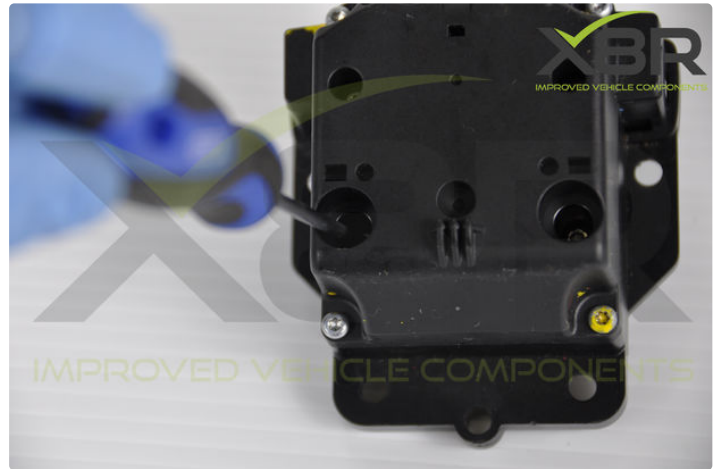
Step 5: Separate the Two Halves

Now the screws are removed you can separate the two halves of the unit. Ours came apart quite easily but you may need a plastic pry tool or flat head screwdriver to separate them if it proves tough.

You will now be able to see the insides of the unit and its time to take extra care not to damage the components or the circuit board as this could lead to a malfunctioning unit even with our new shaft fitted.

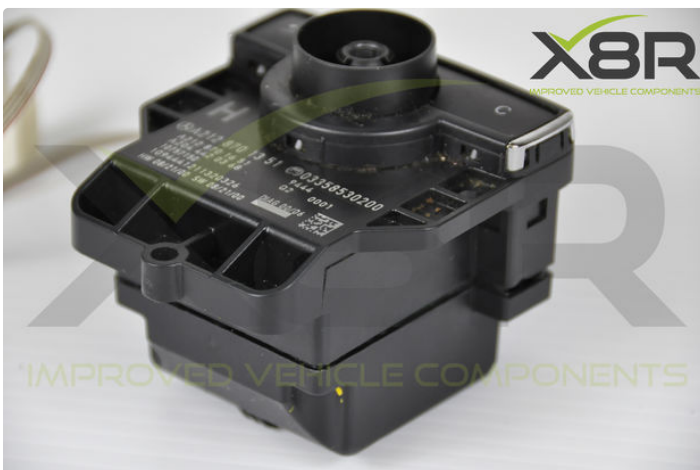
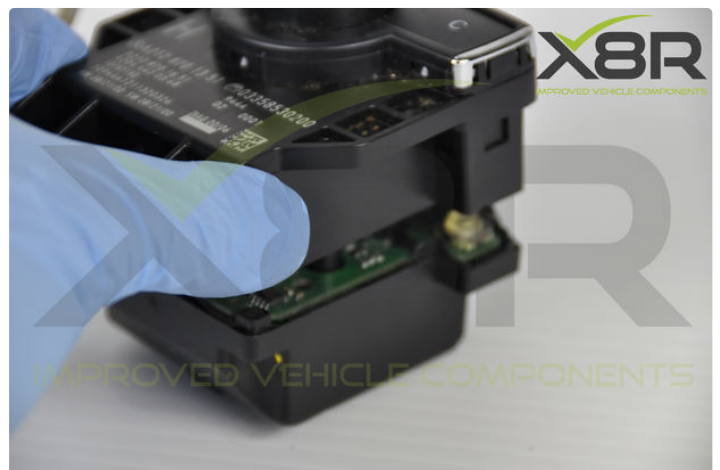
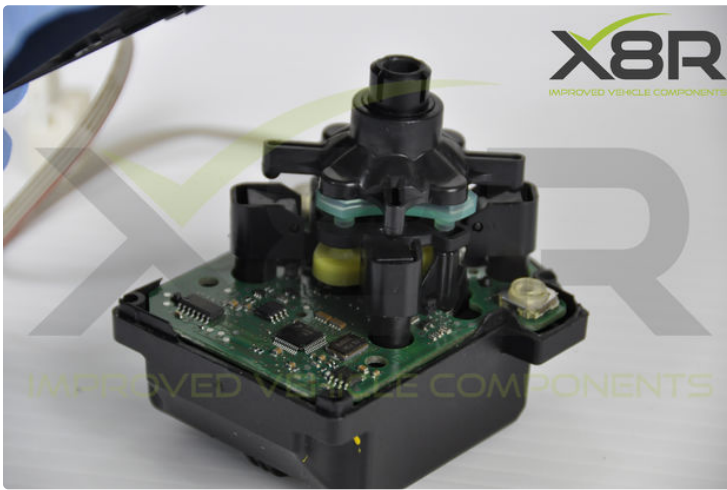
Step 6: Remove the Shaft Components

Carefully lift away the 4 components that are located around the shaft cover.

Important! Place these in the order they came off as they will need to be placed back in the correct order for the unit to work properly.

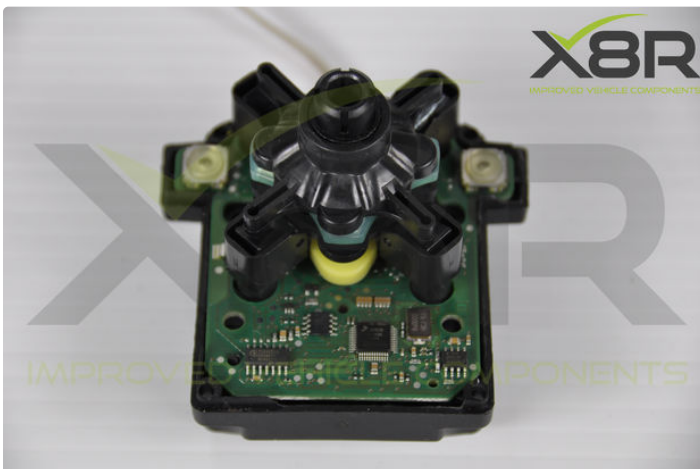
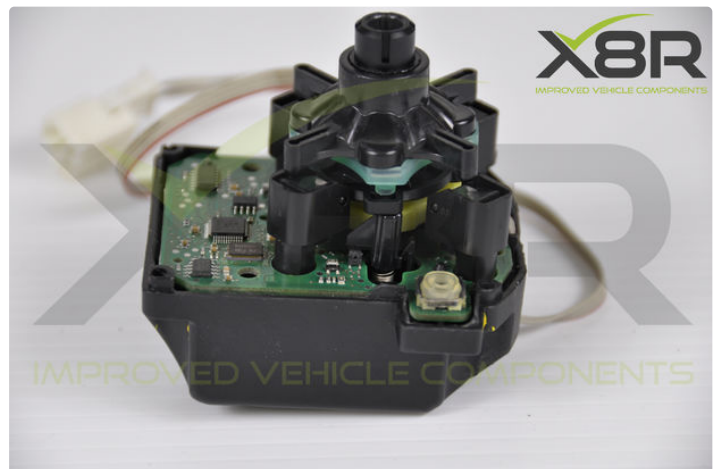
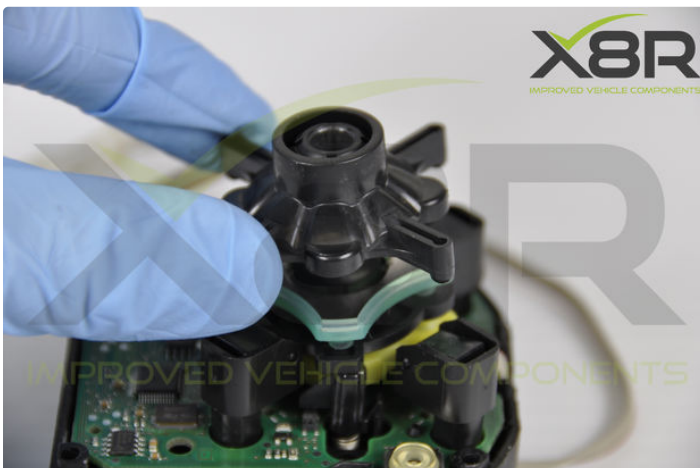
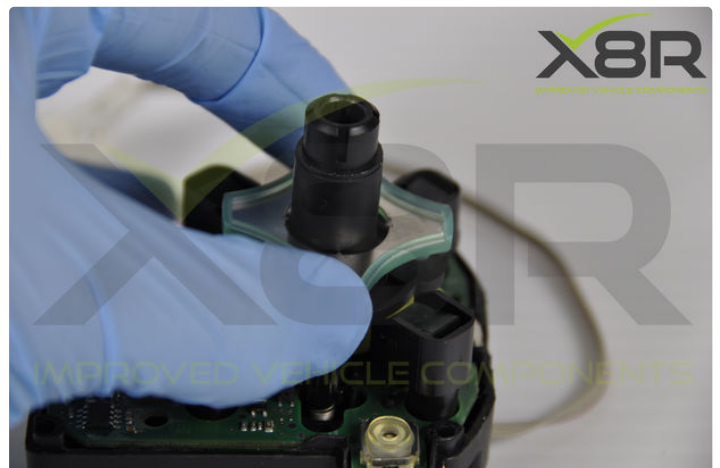
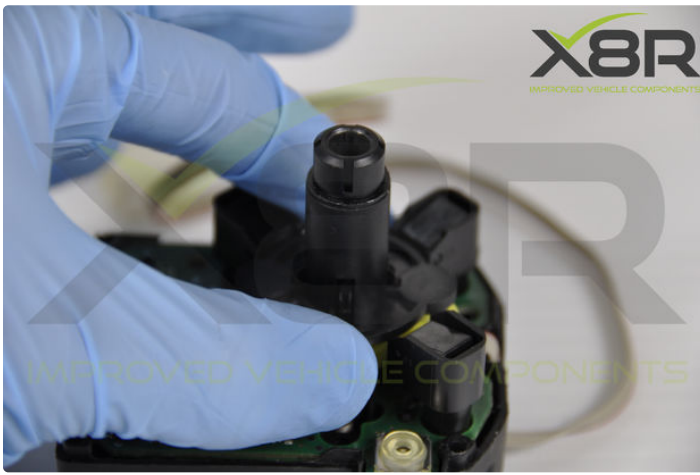
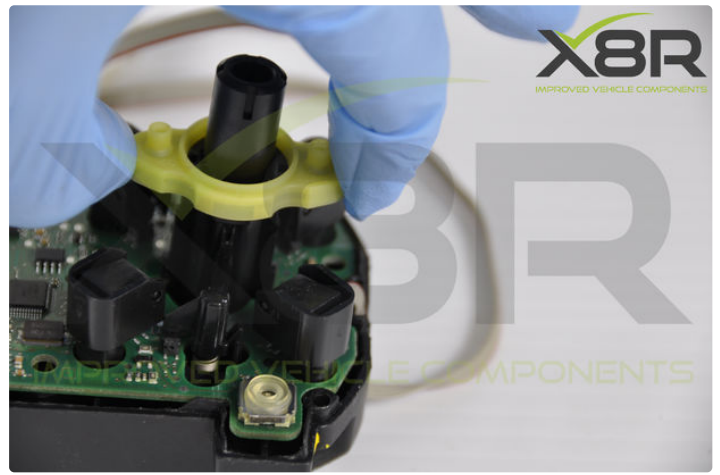
Step 7: Remove Small Plastic Levers

You will now need to remove the 4 small levers from the 4 plastic housings.

Carefully use a small flat head screwdriver to pry the levers out being careful not to damage anything. Store these safely.

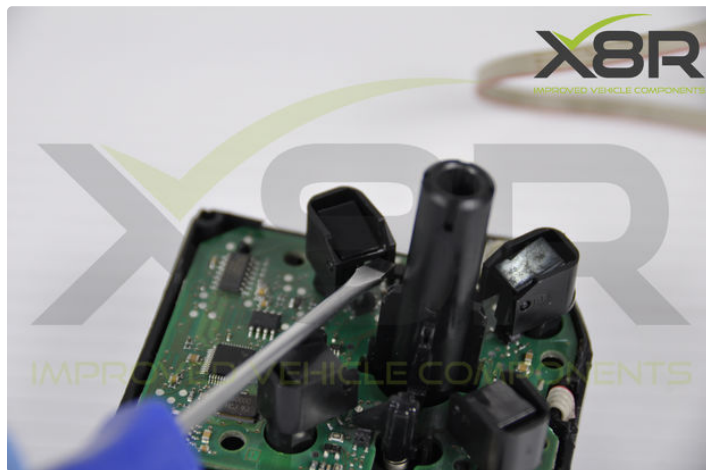
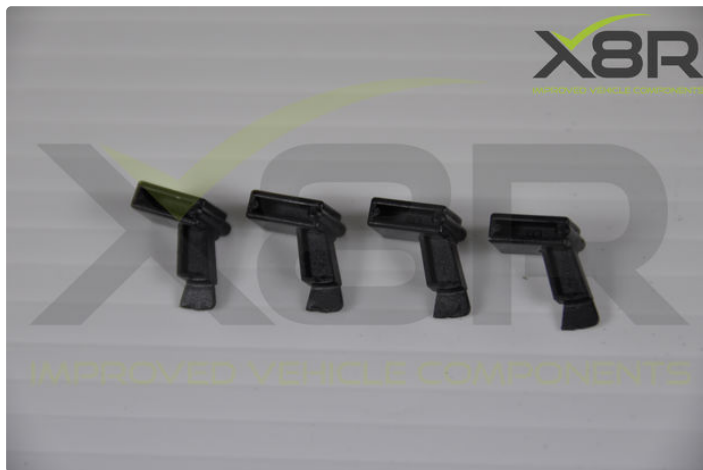
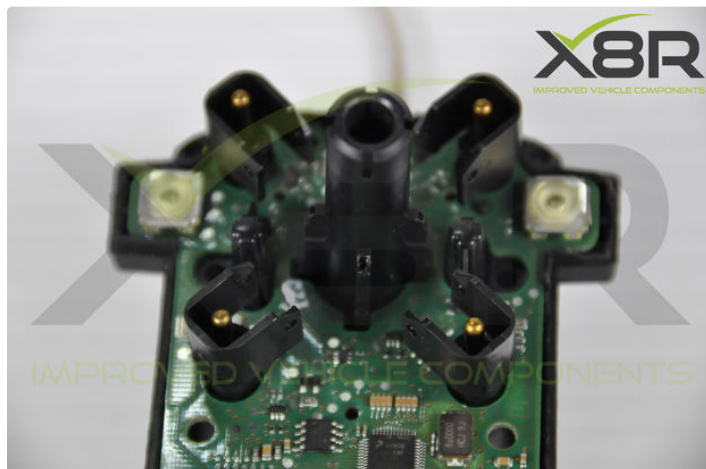
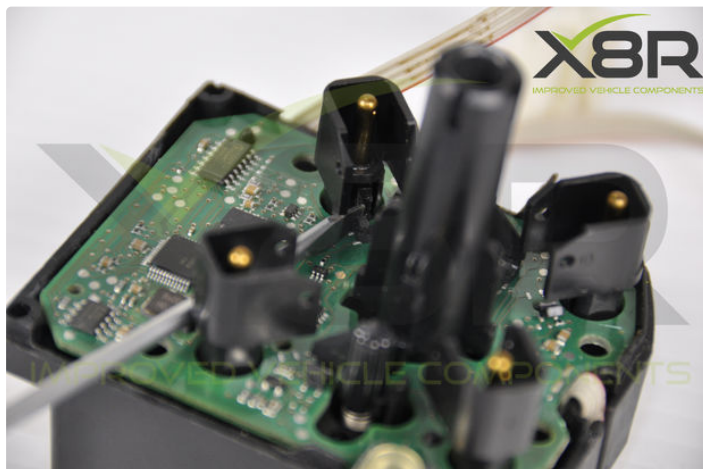
Step 8: Remove the Lever Housings

Using a small flat head screwdriver, gently pry the tab outwards and then pull the housing upwards to remove it from the circuit board. Do this for all 4 housings.

Be careful not to break the tabs by levering them too far.

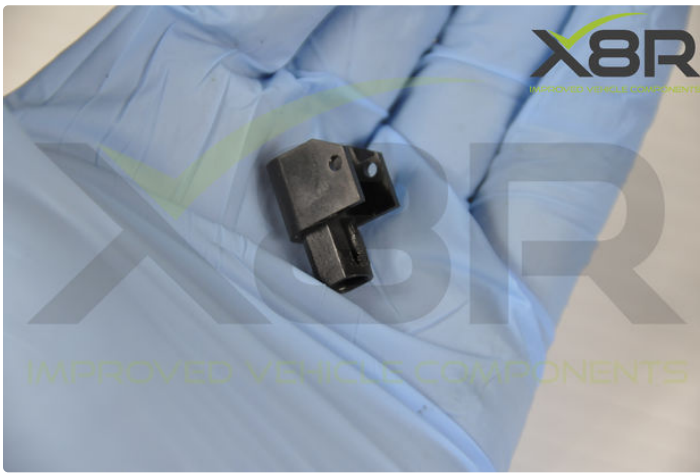
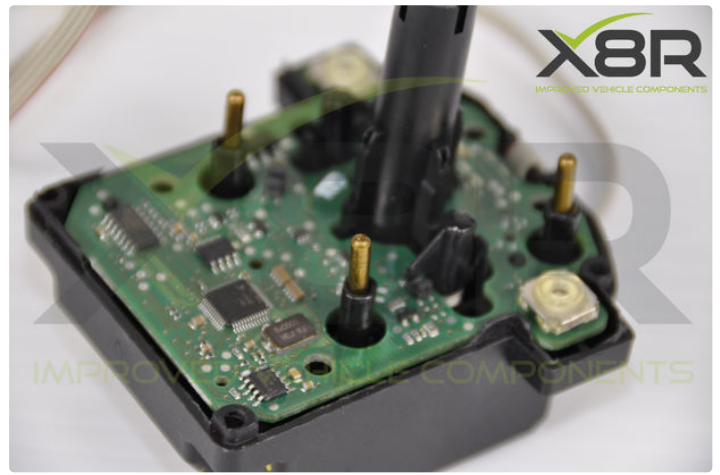
Step 9: Remove the Circuit Board

Firstly, remove the wiring from its retaining plastic channel on the unit housing.

Once this is free, very carefully lift the circuit board away from the rest of the unit up over the shaft cover.

Store this safely.

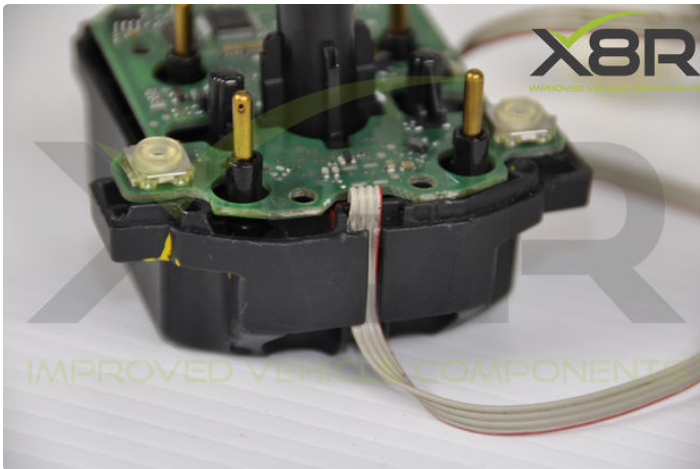
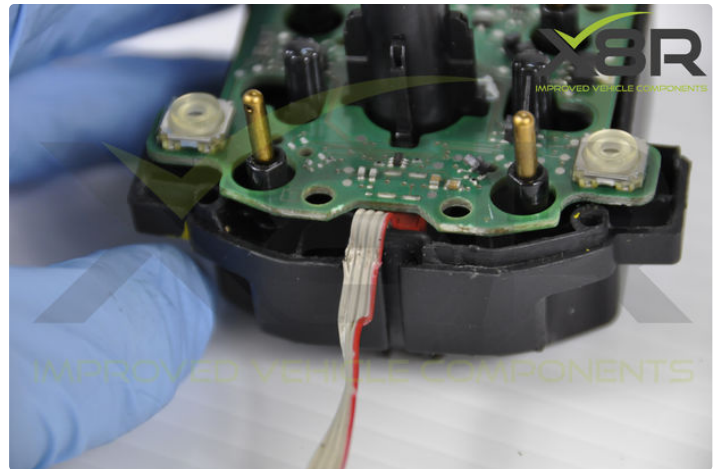
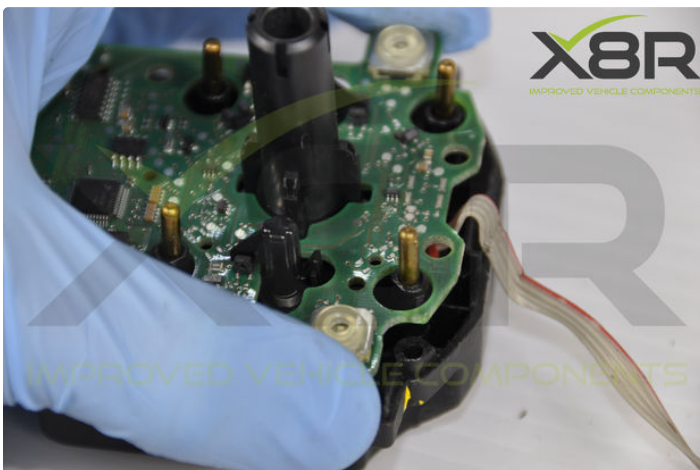
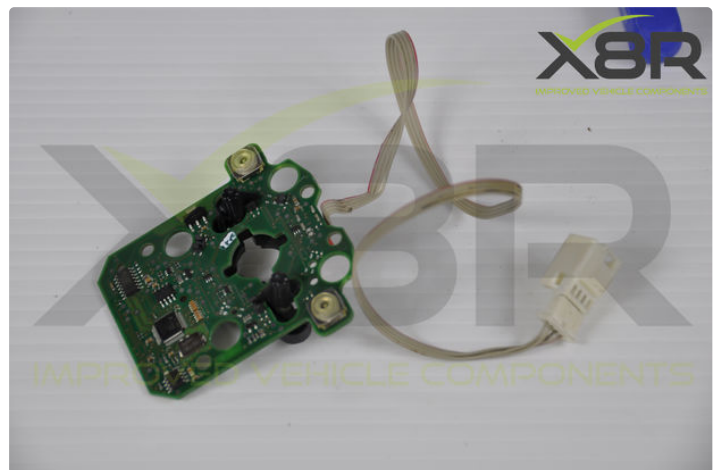
Step 10: Remove the Shaft Cover

You can now remove the plastic cover that protects the control shaft.

This will just lift away and will reveal the broken shaft which has been causing the issues with functionality.

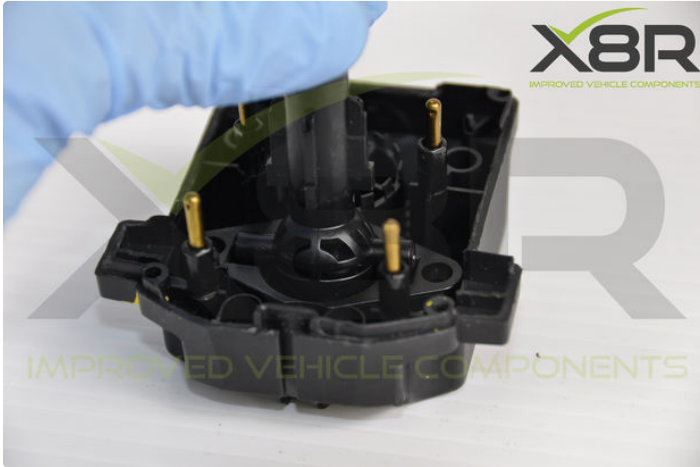
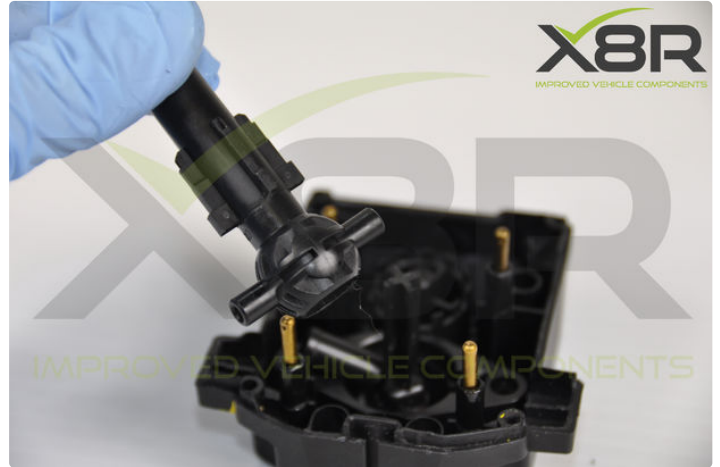
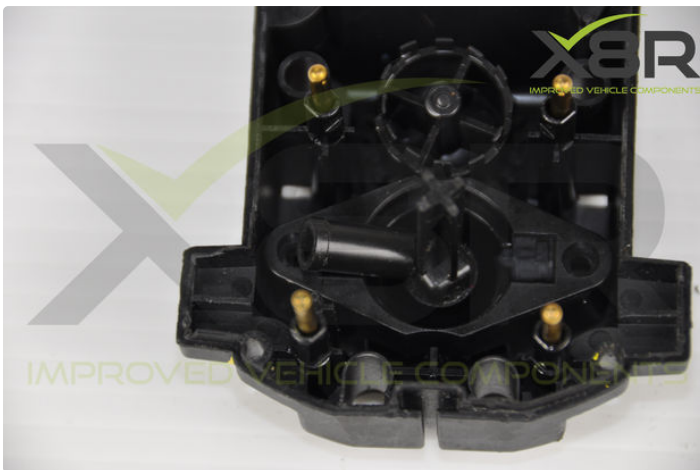
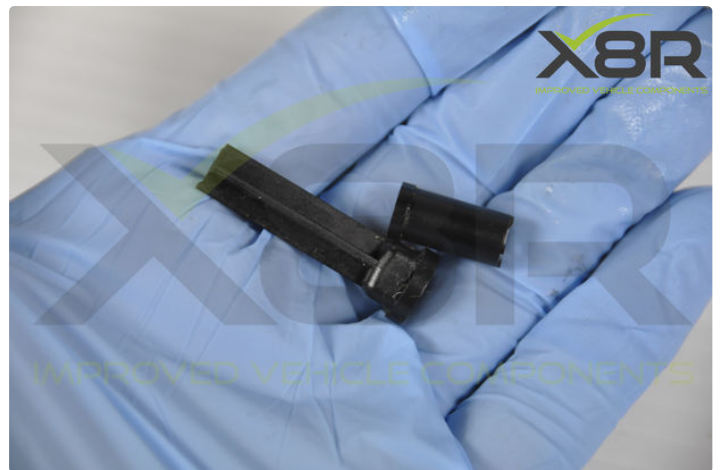
Step 11: Check the Units Parts

Make sure you have safely stored or placed all the parts you have removed.

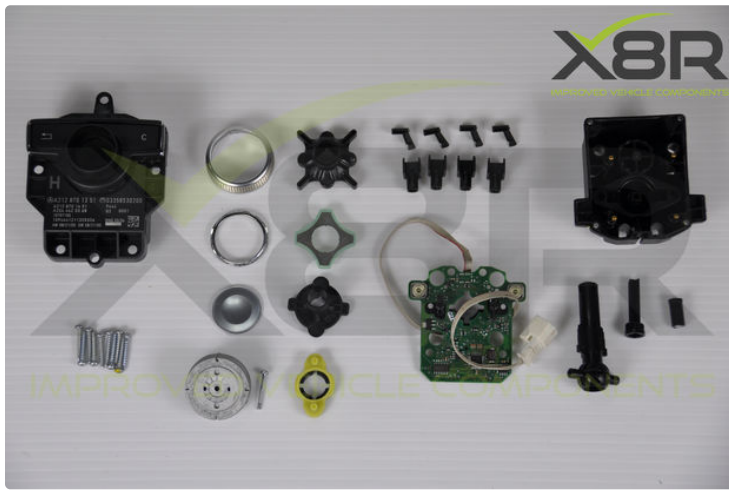
Step 12: Fit Our Aluminium Shaft

It is now time to fit our aluminium shaft and rebuild the unit.

The shaft just needs to be placed on the bottom locating square and then the plastic shaft cover can be placed over the top of it to hold it upright.

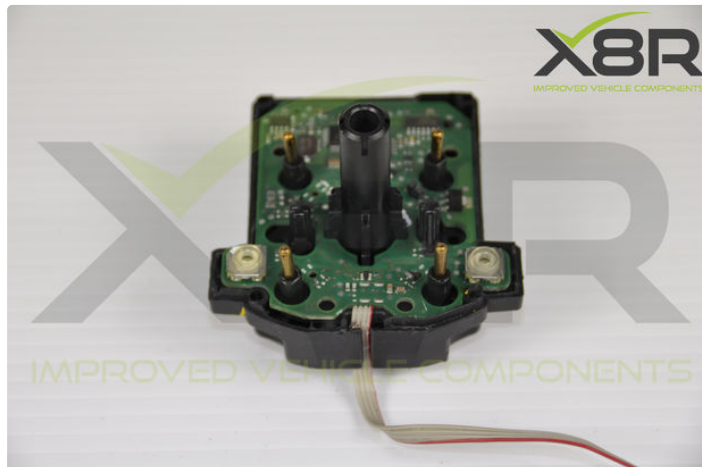
Step 14: Reinstall Levers

Its usually best to reconstruct the lever into the lever housing BEFORE installing them back onto the circuit board.

These just clip into place and make sure the "leg" of the lever faces down and outwards.

Once the 4 levers are back in their housings, the housings can be push fitted back onto the circuit board.

Make sure the lever legs are facing inwards towards the shaft.

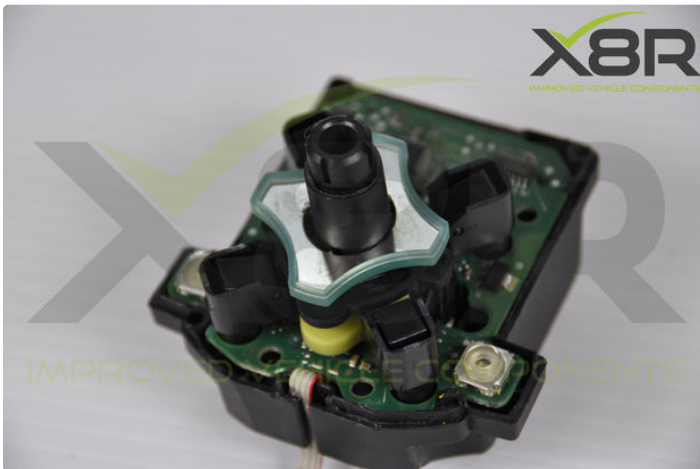
Step 16: Reconnect Two Halves of Unit

You can now place the two halves of the control unit back together. Sit bottom half on your workbench and place the top half down onto it to make sure nothing falls out.

Once joined, hold the unit together and turn it over onto its front to refit the screws with the T10 torx screwdriver.

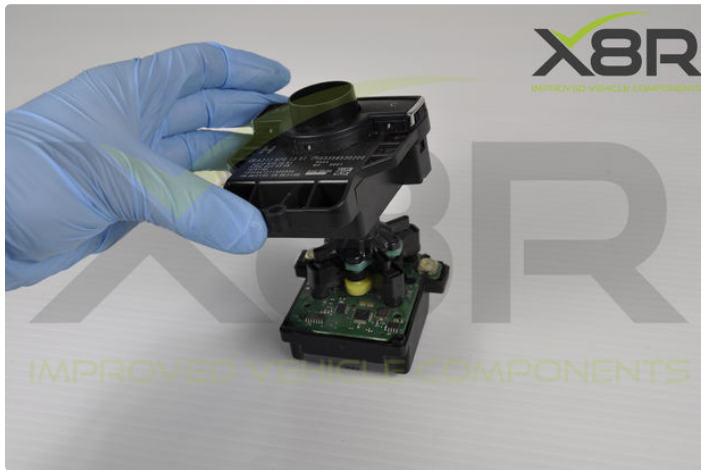
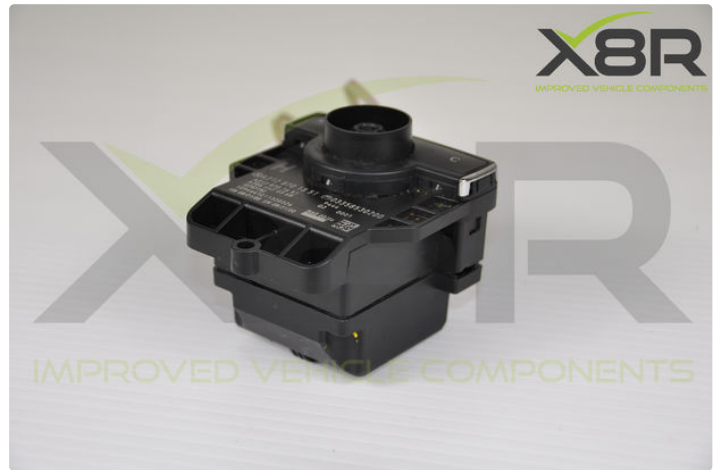
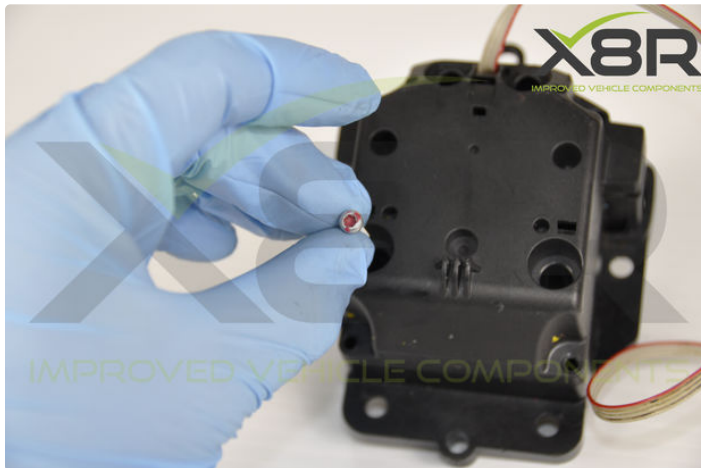
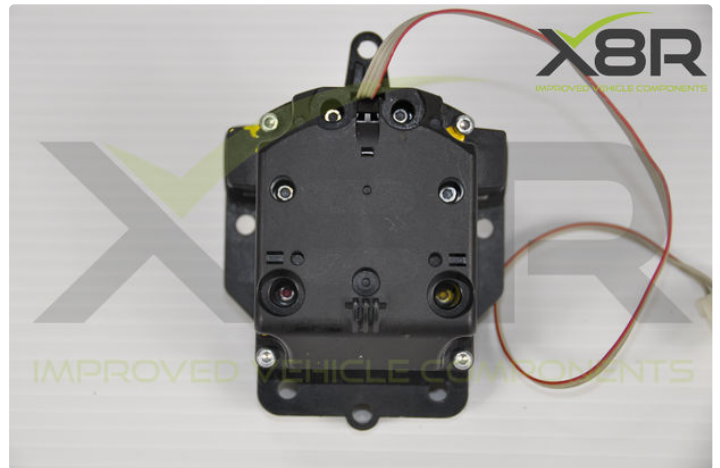
Step 17: Refit the Scroll Dial

Place the dial back onto the unit. Rotate it until it locates correctly.

Refit the screw using the (in our case) T7 torx screwdriver. Do not over tighten this. You will need to apply pressure downwards onto the dial whilst screwing in the screw.

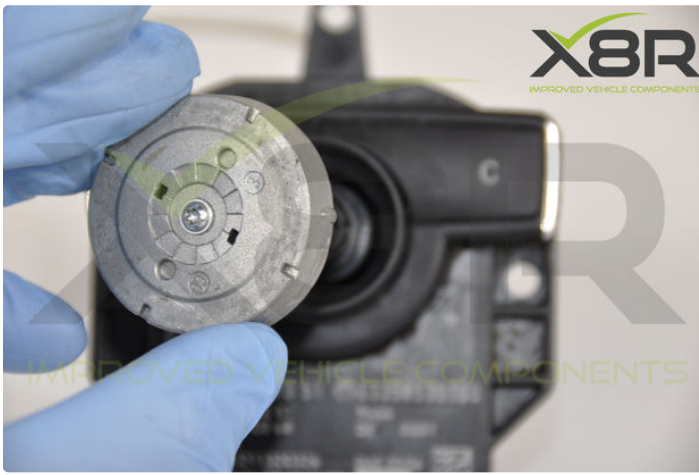
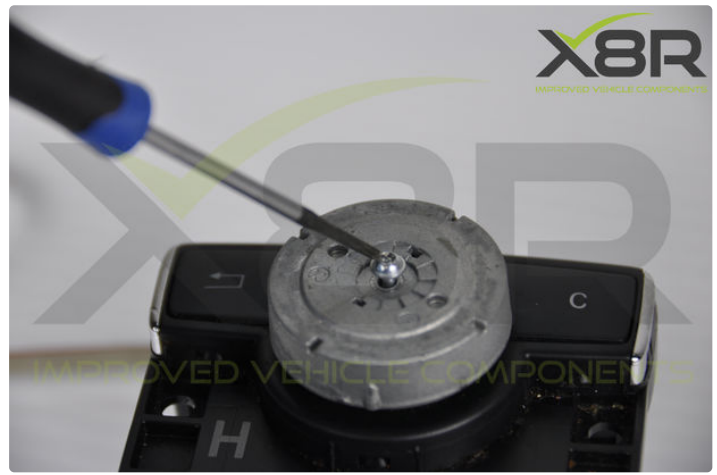
Step 18: Refit the Top Cover, Top Ring and Outer Ring

Place the top button cover on the dial centrally.

The top ring has locating lugs on it that should correspond with locating holes on the top edge of the dial. Place these lugs in the holes and gently press down making sure the the ring is secure around the top cover.

Lastly, refit the outer scroll ring. There are 3 locating strips on the inside of the scroll ring which will slot down into 3 locating grooves on the outside edge of the scroll dial.

Push down until this clicks and it should now be securely in place.
