Mercedes M ML Class W163 1997-2005 Door Lock Actuators Spring Springs Repair Part Kit Fix Install Instructions Guide

Step 1: Fitment of new spring

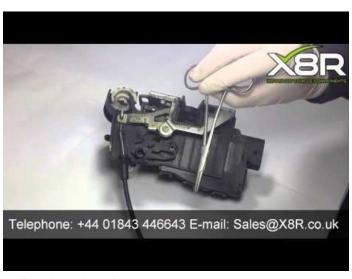
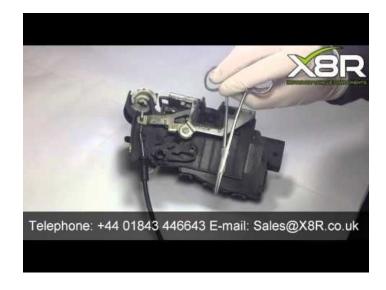
- Grasp the spring with the forceps as shown in the first image.
 Locate the spring end in to the hole on the underside of the black plastic part as shown in the first image, in the second image you can see where the hole is located on the underside of the black plastic part.
- Once located on the underside, rotate the spring and force in to the channel shown in the fourth image.
- Test the function of the actuator.
