Volkswagen Transporter T5 Cup Holder Drinks Holder

Volkswagen Transporter T5 Cup Holder Drinks Holder: Page 2

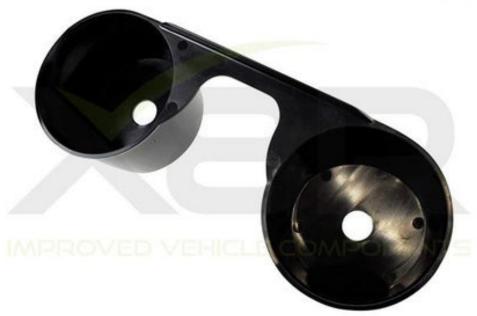
The OEM Volkswagen cup holder works by retracting to & from the dashboard, when it pops out there are two flaps which hold two drinks. However the flaps work on a spring mechanism which often breaks. The flaps also put too much pressure on paper cups (such as those from drive-thrus) and can cause them to spill.

We have created an improved design cup holder insert which has been injection molded for precision and quality. The insert also makes it far easier to insert a drinks cup or bottle whilst driving

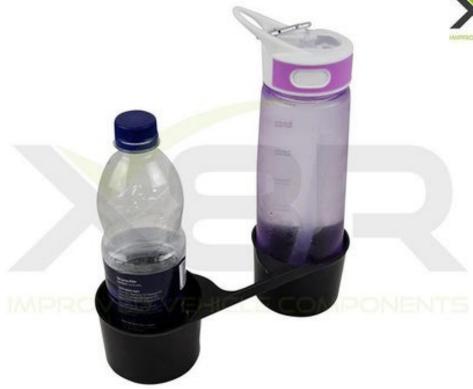
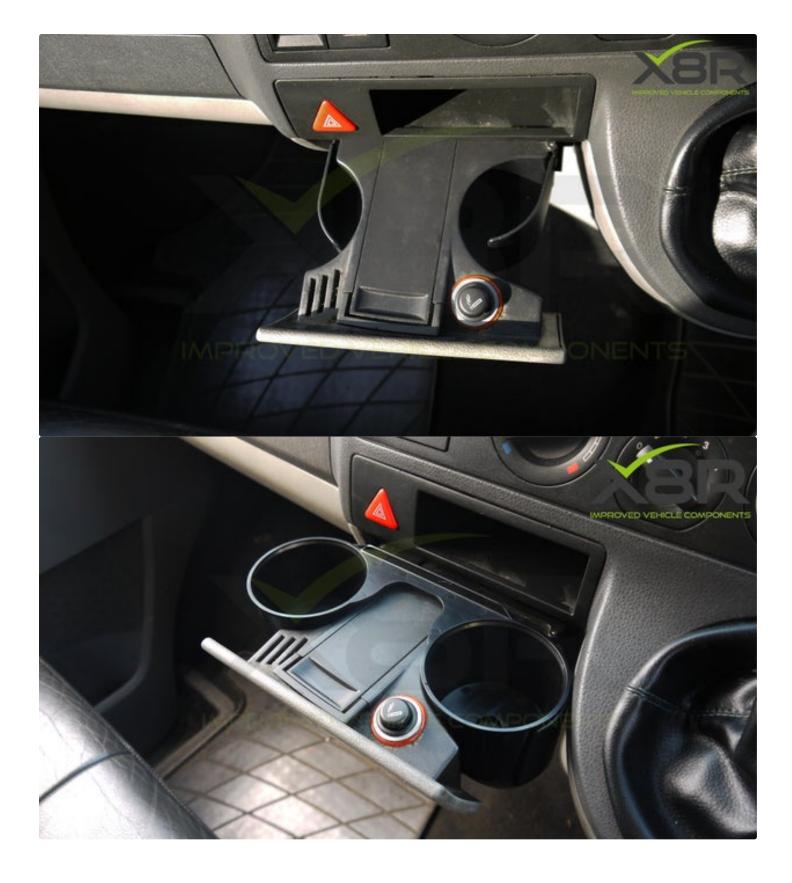
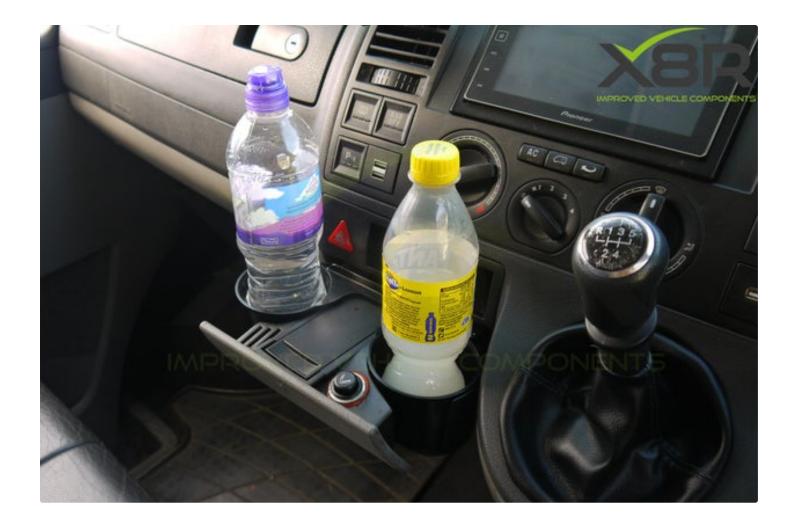
Step 1: Fit the Cup Holder

Pull out the cup holder tray from the dashboard and insert the cup holder insert between the flaps. Even if one of the sides is broken you should still have the cup holder insert fitting firmly.
