X8R0253 Universal Heat Shield Repair Kit

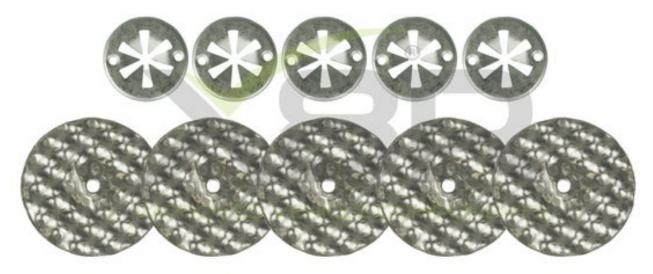
Step 1: Remove Old Fasteners

The first step of installing this repair kit is to remove the damaged old fasteners, as well as cleaning away any debris and rust to prevent this from spreading to other areas. Do so with a wire brush.

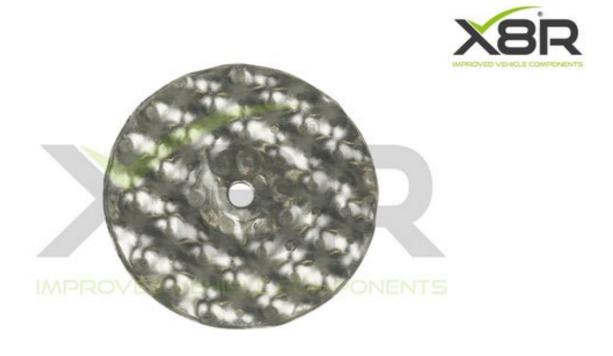
Step 2: Press on Heat Shield Washer

Position the heat shield, and press on the heat shield washer, making sure that it is in the correct position.

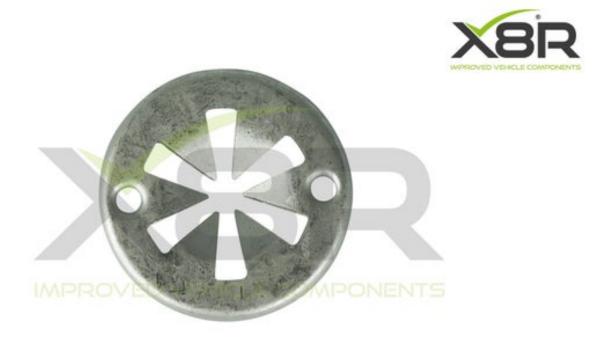
Step 3: Secure the Star Locking Washer

Press on the star locking washer by hand. Secure it by using a socket and a rubber mallet, or you can just press these on with screwdrivers or other blunt tools. The repair is complete once the items are securely fastened.
