## Mini R52 R57 Improved Rubber Roof Seals

### Introduction: Mini R52 R57 Improved Rubber Roof Seals

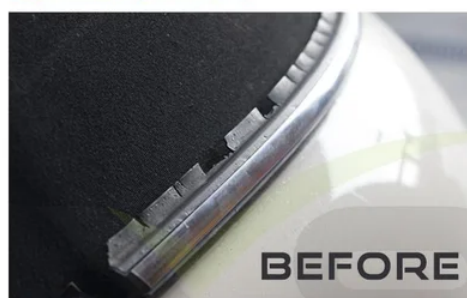
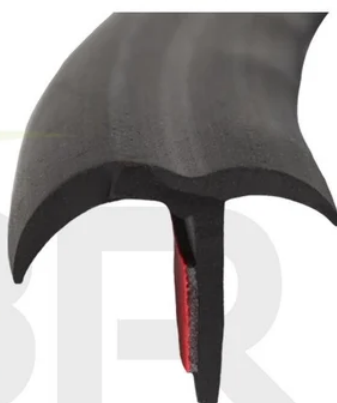
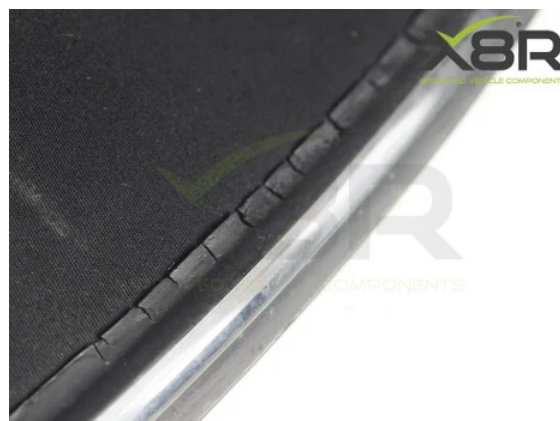
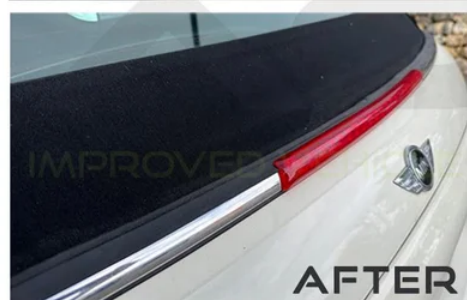
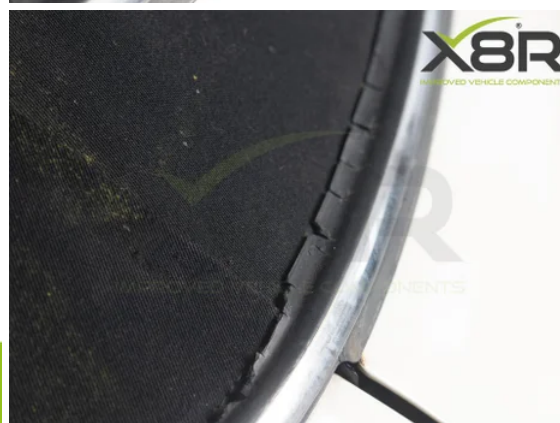
**EXTRUDED FOR THE MINI CHROME TRIMS BY X8R  
- NOT GENERIC RUBBER LENGTHS!**

Fit the unique X8R rubber roof trims to restore your Mini and make it look brand new again

X8R Ltd have developed a new and improved profile of rubber trim to repair the Mini convertibles (R52 and R57). The profile is made specifically for X8R and not available for purchase anywhere else. The profile is uniquely molded to fit the exact design of the OEM trims, and simply sticks onto the back of the plastic trims and folds over the top of the old rubber and makes your car look brand new.

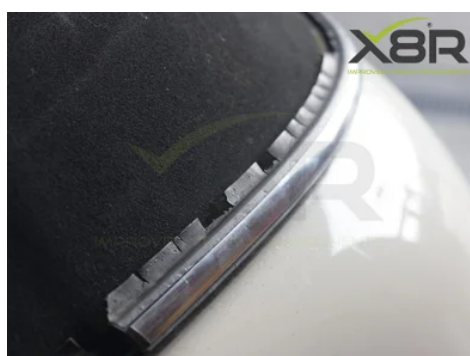
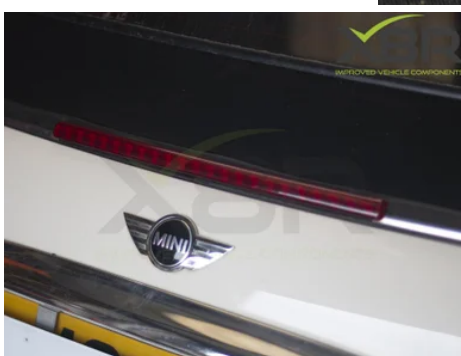
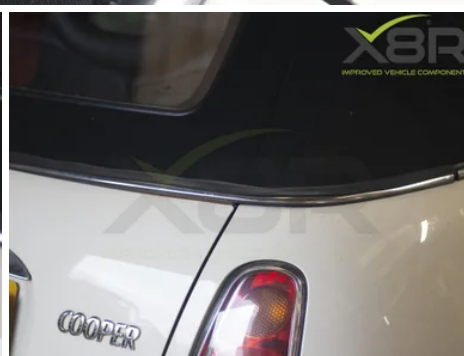
The rubber strip will become cracked and begin to flake away. You may notice a build up of dirt in the void underneath the top edge of the boot hatch.

Depending on how serious the leak is, there may even be some rust beginning to develop from where water has leaked past the seal which meets the canvas roof.

The factory installed weather strips on these cars tend to perish and become cracked over time when exposed to sunlight and adverse weather conditions.

This can result in water leaking behind the chrome trim and cause corrosion to form on the inside of the metal panels.

The original Mini seals are made from a rubber which becomes hard and brittle over time, resulting in them failing.

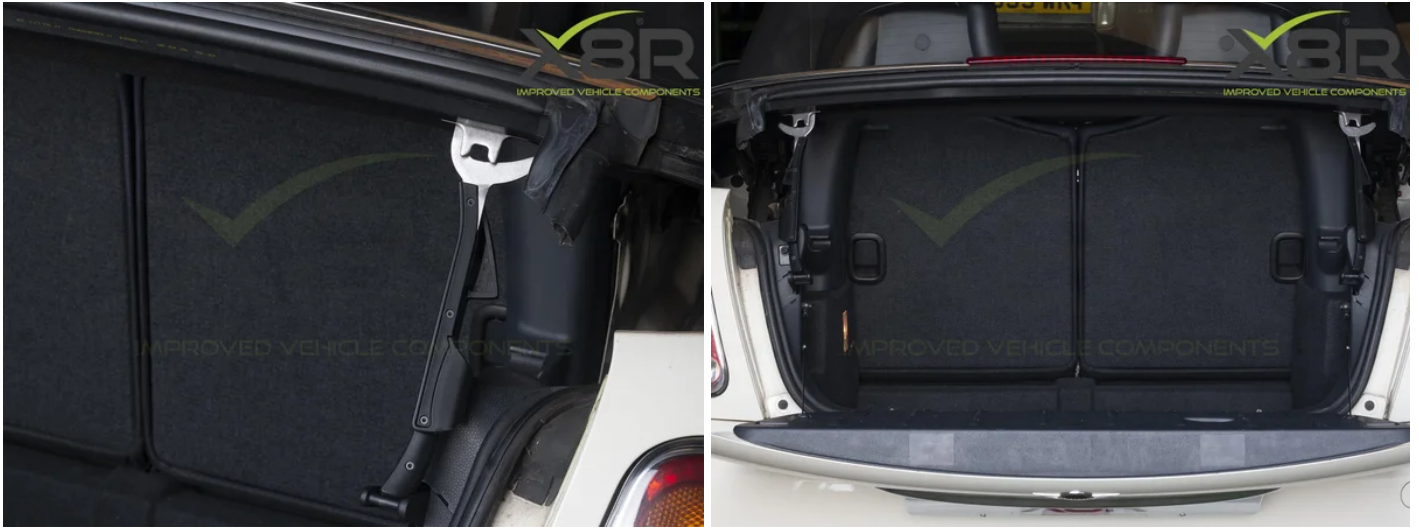
## Step 1:

There is a latch at either side of the boot, lift these into their horizontal position to allow the canvas canopy to be raised. Move the arms into position to support the roof.

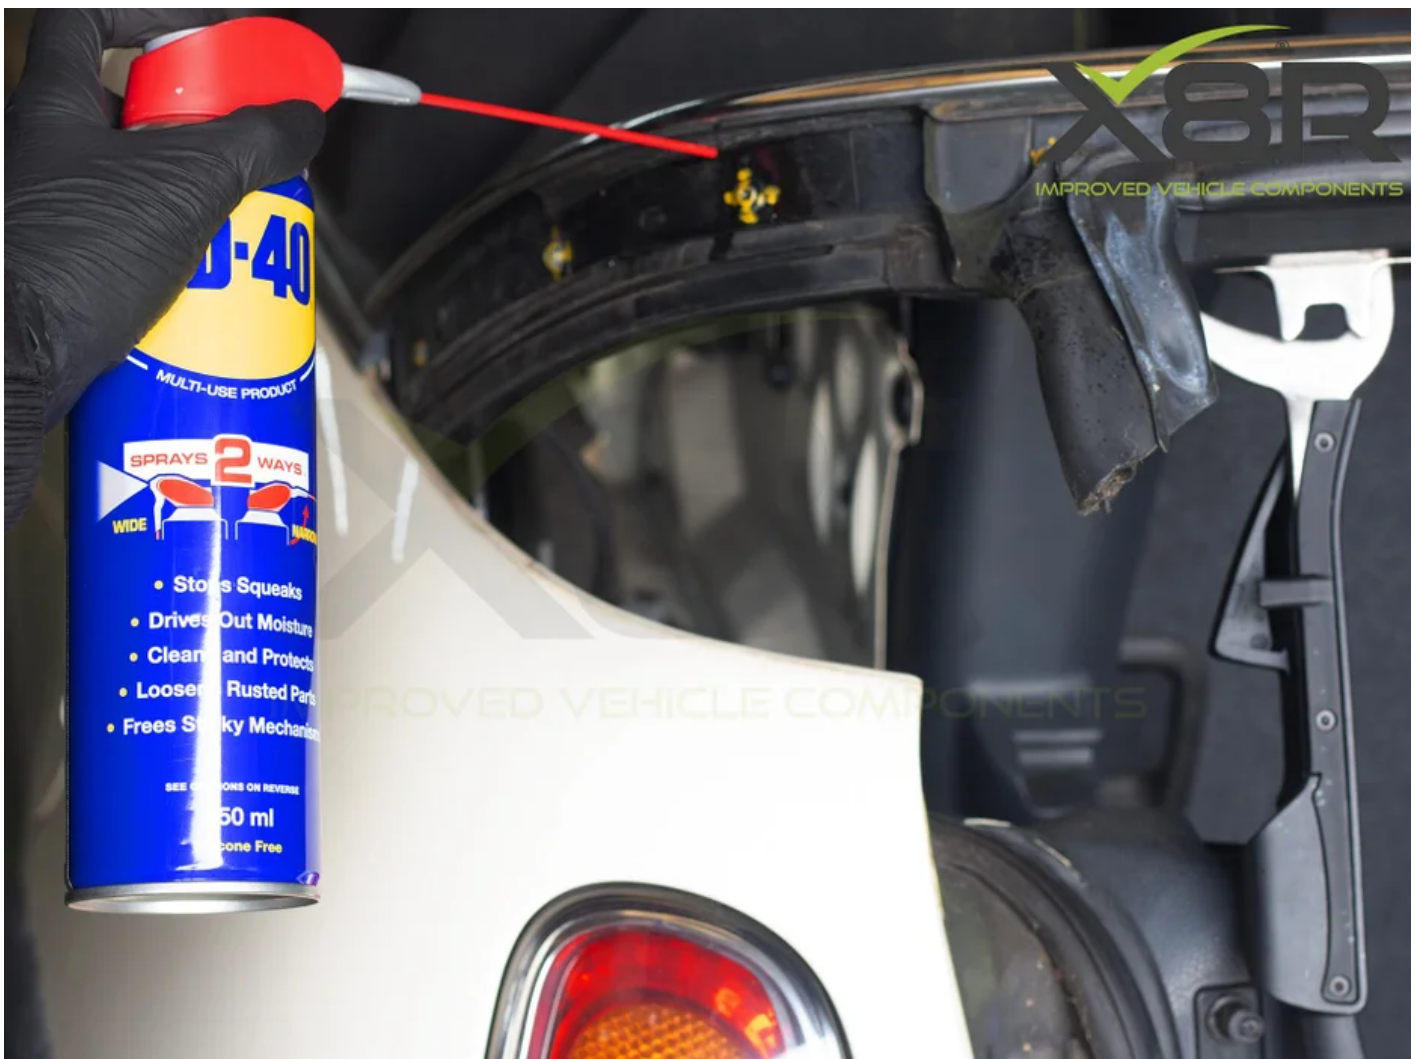
## Step 2:

If the screws are tough to remove, apply WD40 to all 14 of the screws that retain the chrome trims.  
*This step is optional.*

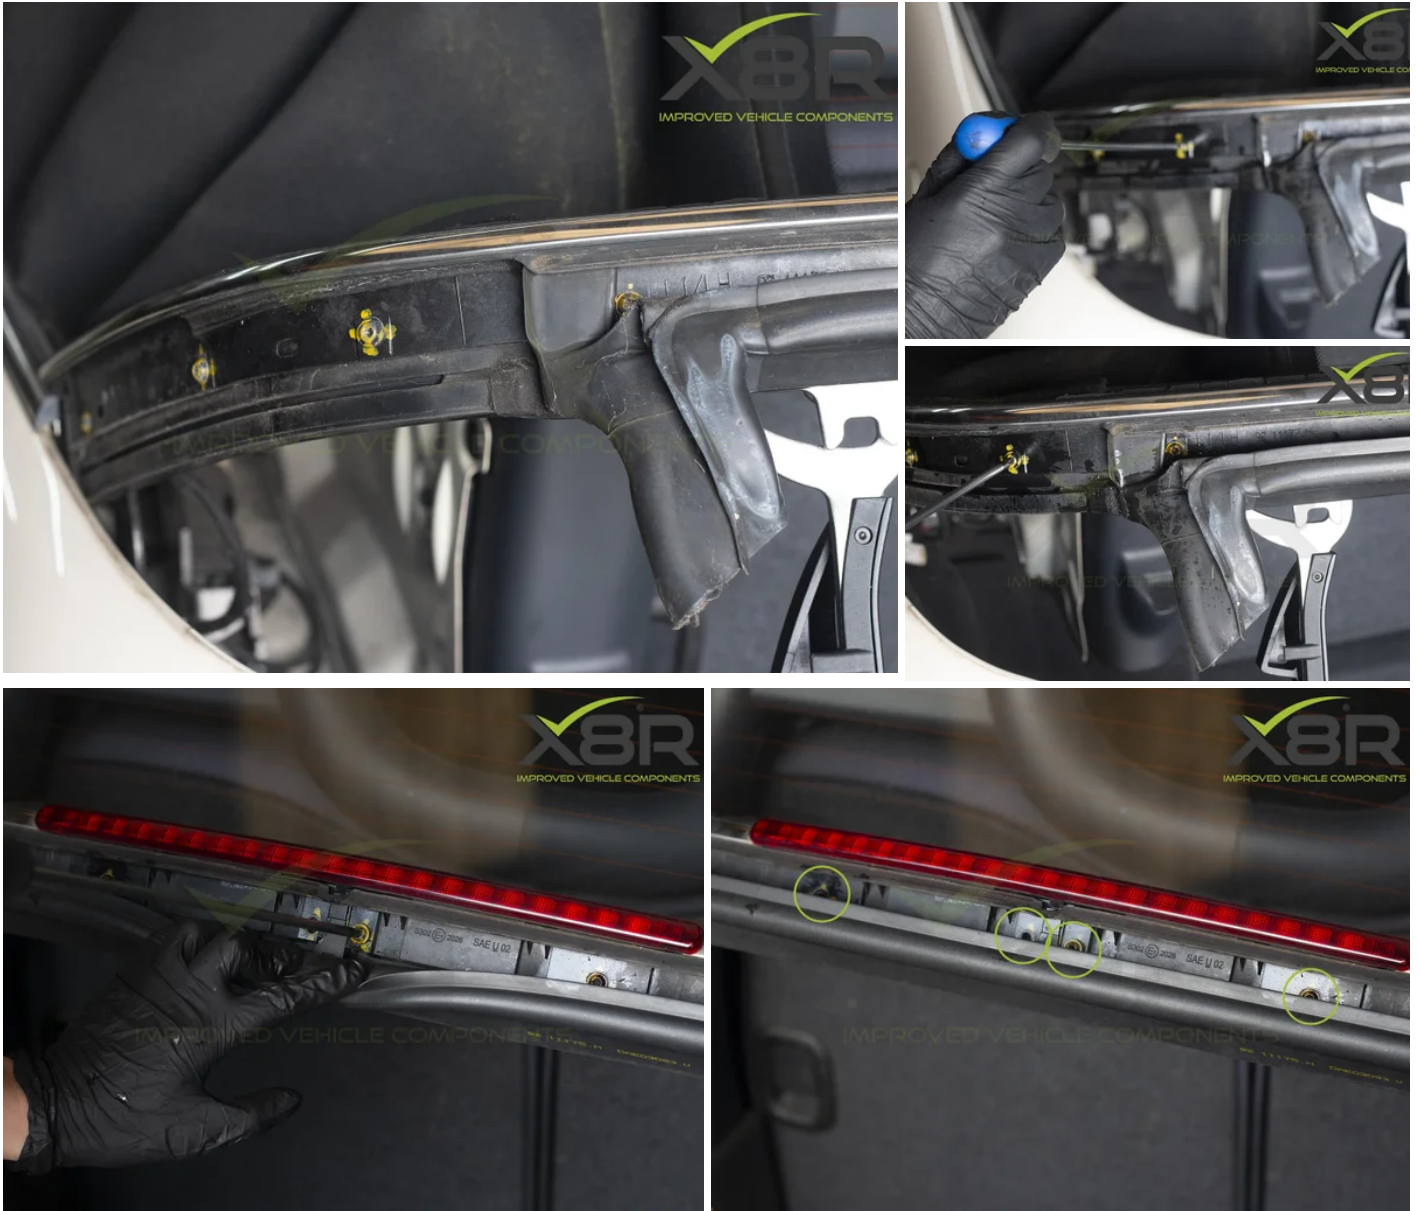
## Step 3:

Remove all 14 screws that retain the chrome trims. Please note that the central 4 screws (the screws that retain the high level brake light) have a slightly longer thread.

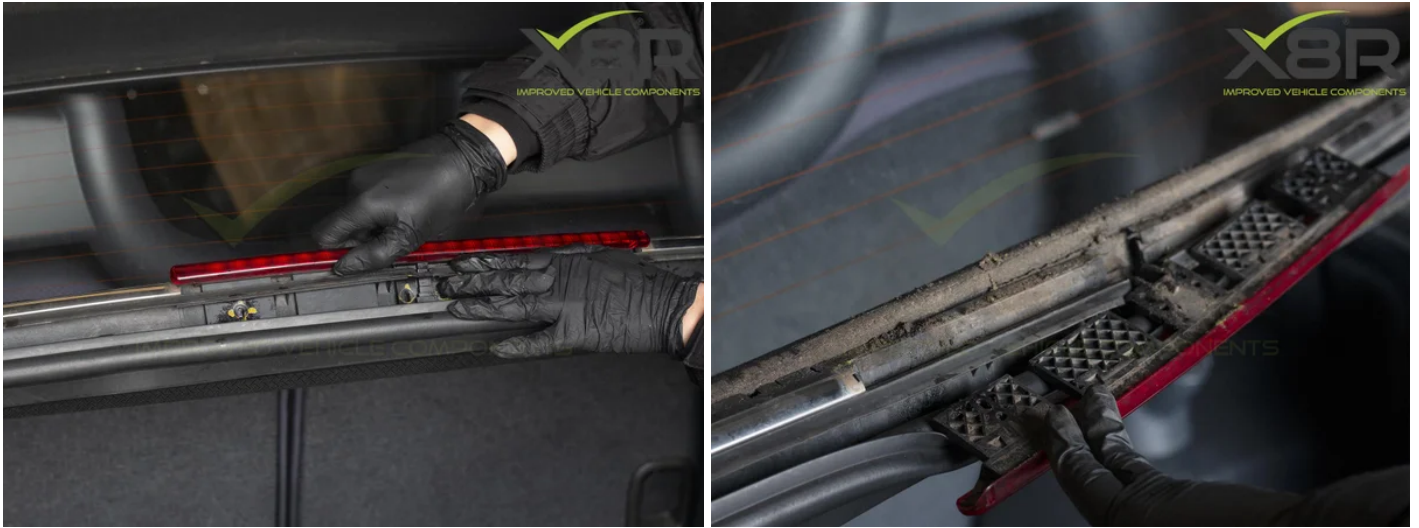
## Step 4:

Pull the high level brake light up and out of the chrome trims. The wires will remain attached to the vehicle. Carefully place the light on it's side as to not damage the wires. Pull the chrome trims away from the vehicle.

There may be a lot of dirt ingress behind the light/trims. Take this opportunity to clean the canvas roof.

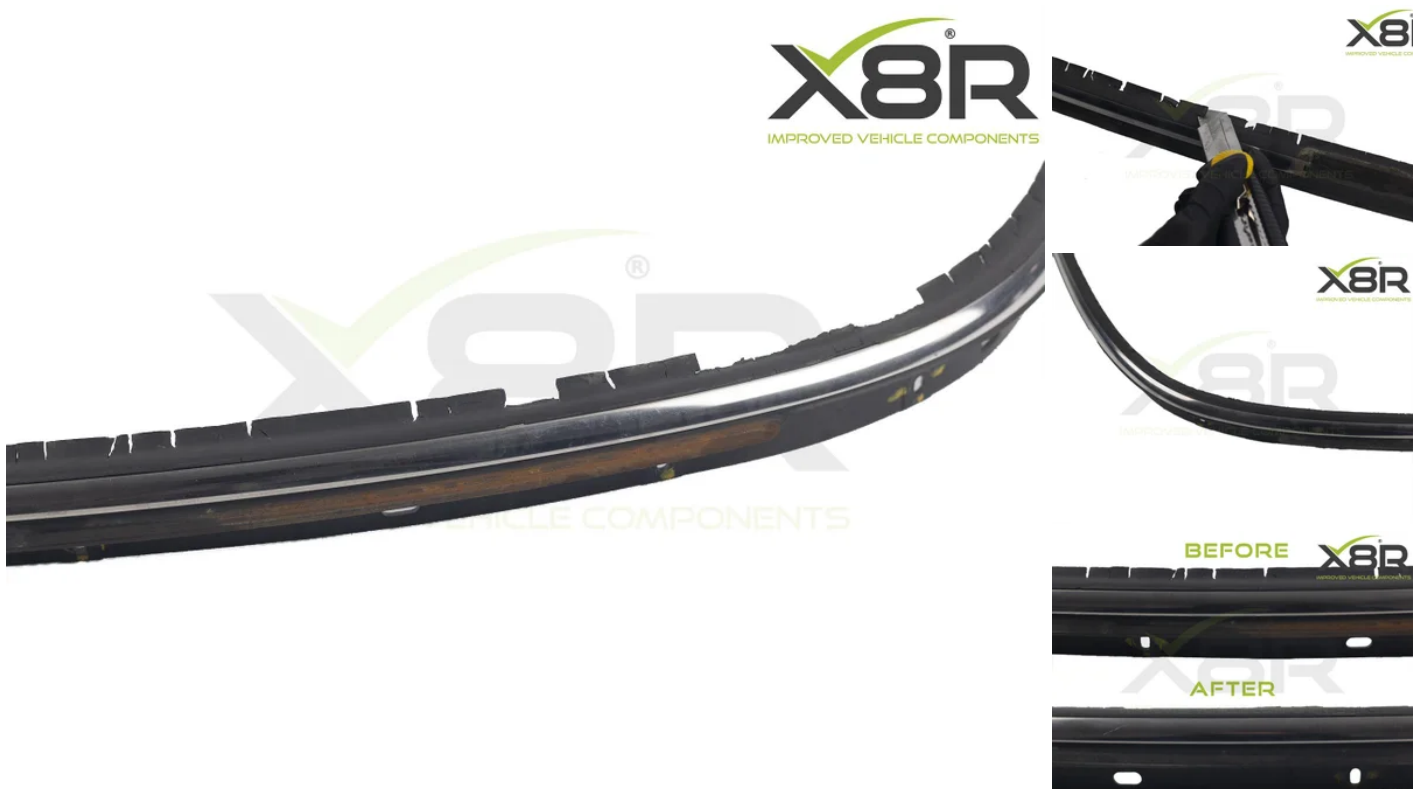
## Step 5:

Use a Stanley blade to cut away the old seal. Only cut away the top section where the rubber sits on the canvas roof. Do not cut too much away as the replacement X8R rubber trim will cover the old trim.

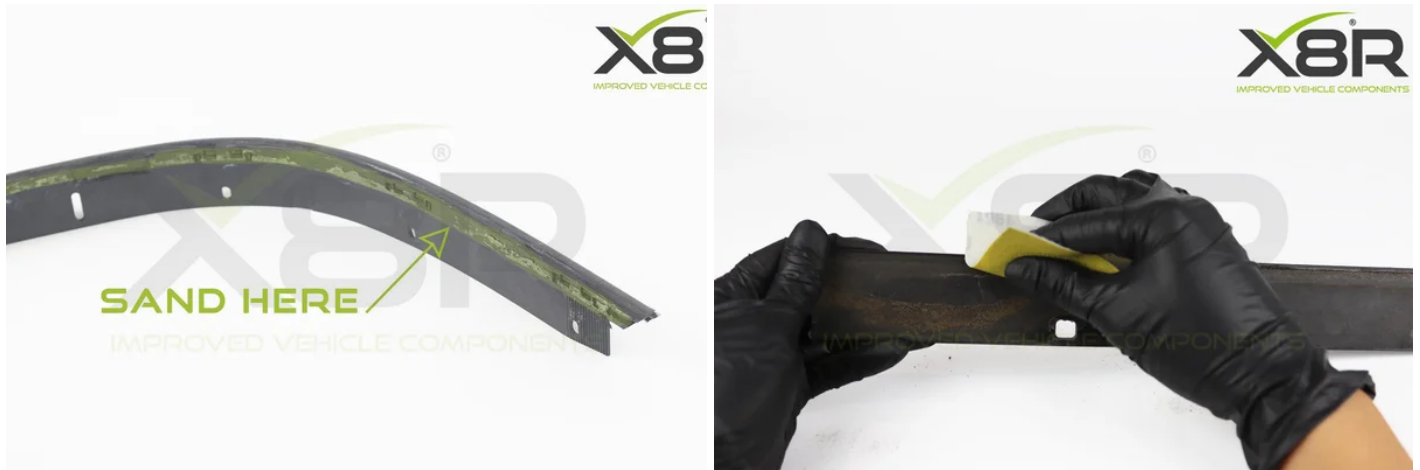
## Step 6:

Use the sandpaper on the back of the chrome trims. This creates a rough surface for the seal to adhere to. You could also use a Dremel with a sanding drum attachment if you have one.

Only sand the back of the plastic where the double-sided tape will stick to, you do not need to sand down the entire plastic trim.

Take care to not scratch the chrome.

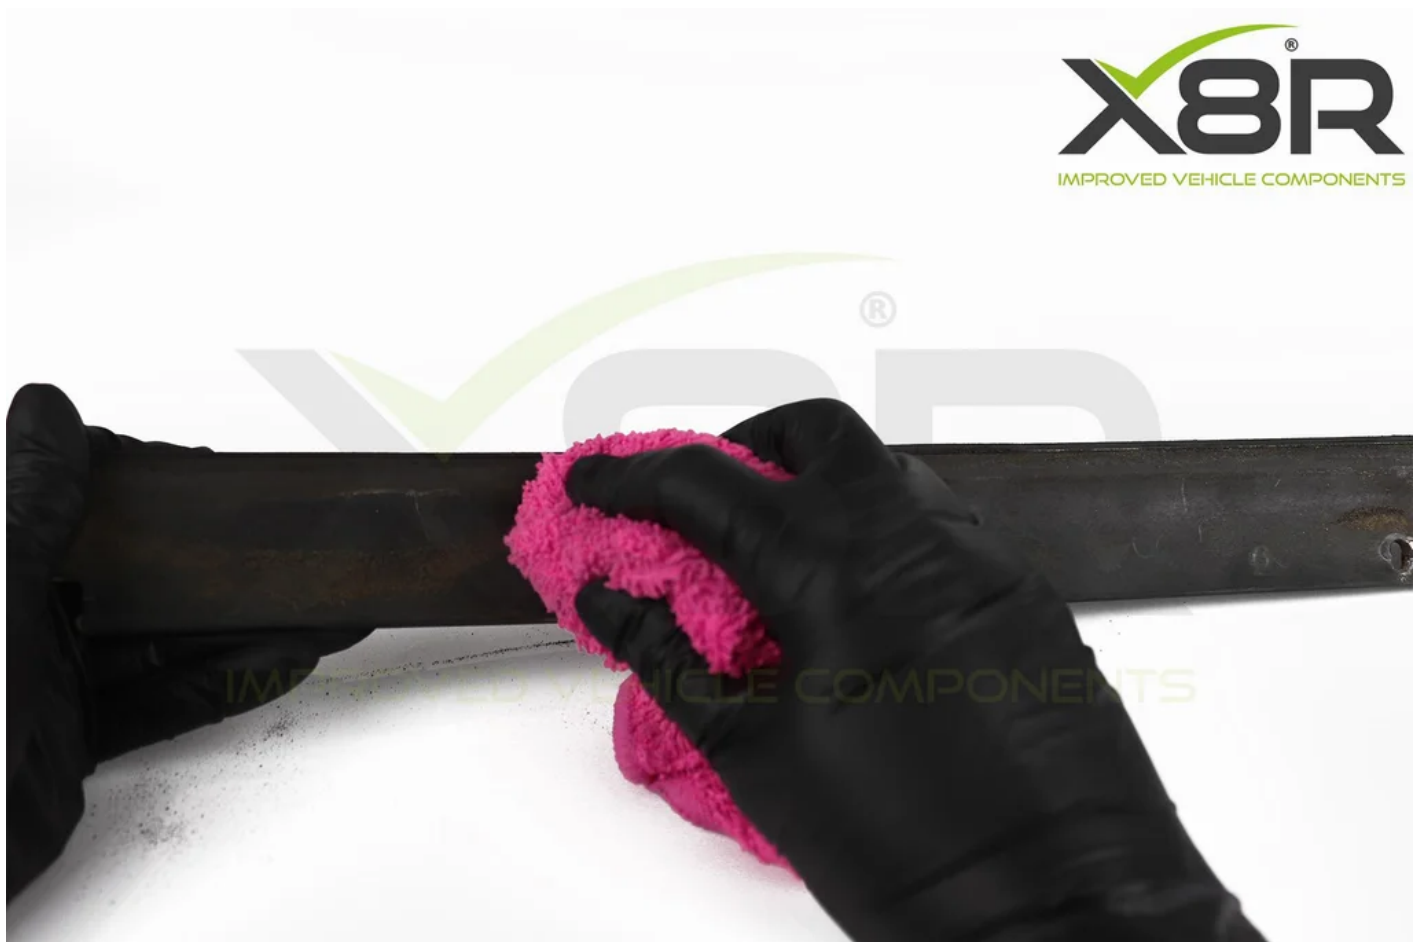
## Step 7:

Thoroughly wipe down the back of the plastic trims. Be sure to remove all dirt, debris and dust from sanding. Any dirt left on these trims may prevent the double-sided tape from being as effective.

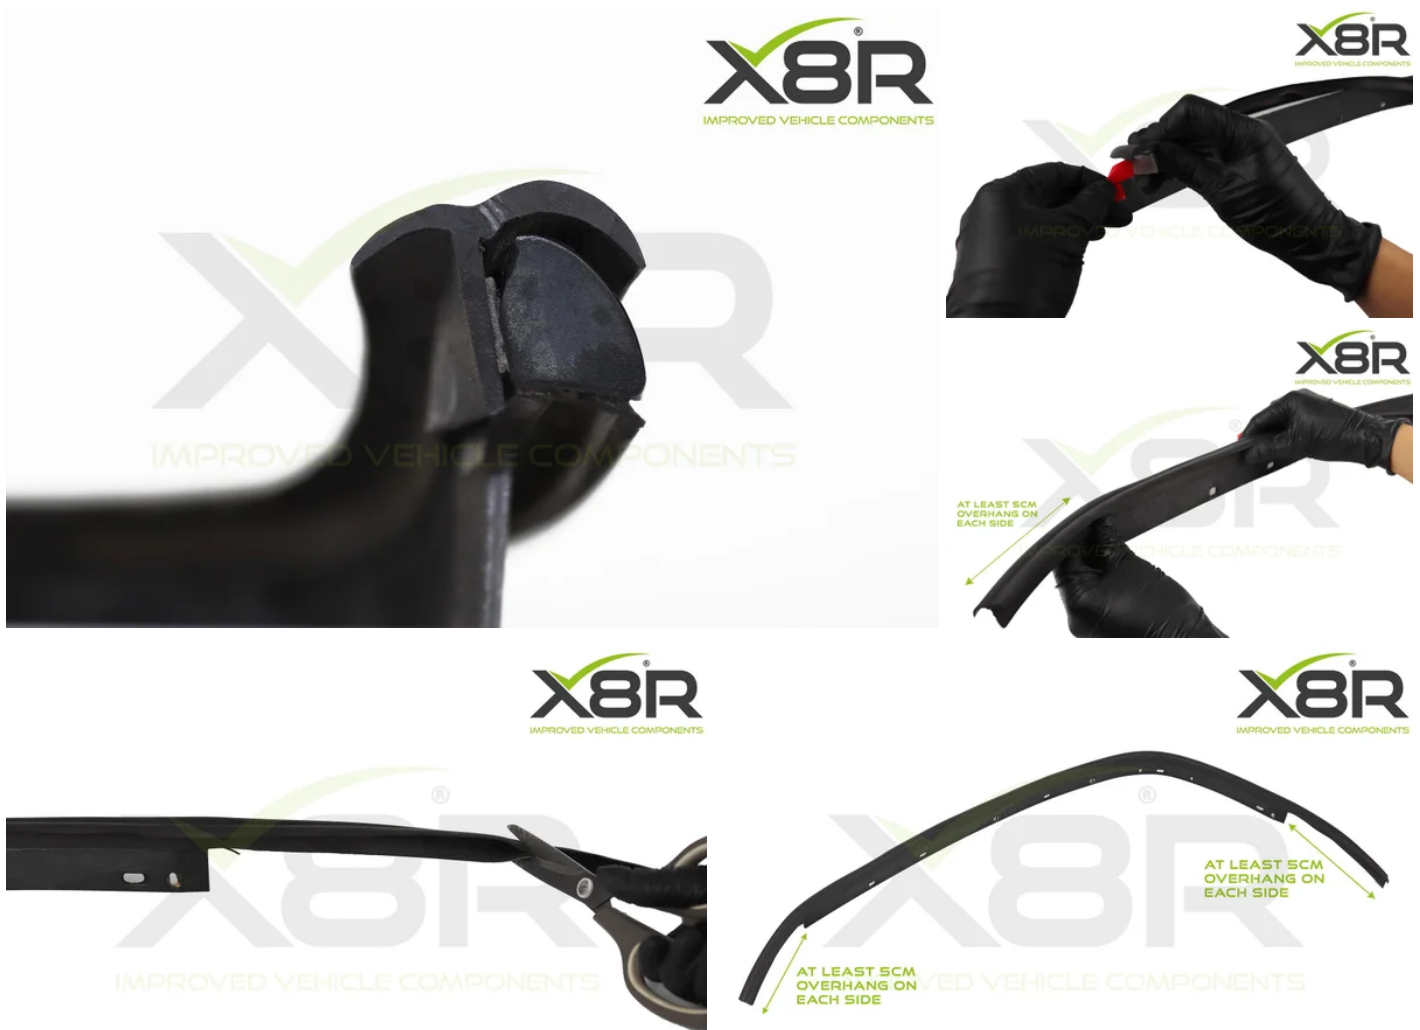
## Step 8:

**Do this step in small sections at a time.**

Peel back a small section of the double-sided tape. Place the tape on the back of the chrome trims and ensure the flap that sits over the top of the chrome piece is perfectly aligned. Once one section is complete and sitting flush, move onto the next. We worked in roughly 10-20cm sections at a time. Do this all the way along the trim.

Ensure that there is a slight overhang of at least 5cm on both sides of the chrome trim (we will trim them down to size later). If there is a lot of trim overhanging, cut off any dramatic excess.

Then fit the other side of the trim.

*Optional - If there are any sections that you find are not sticking as well as you would like, use a small amount of superglue. Be sure to wear appropriate gloves. Use the superglue sparingly.*

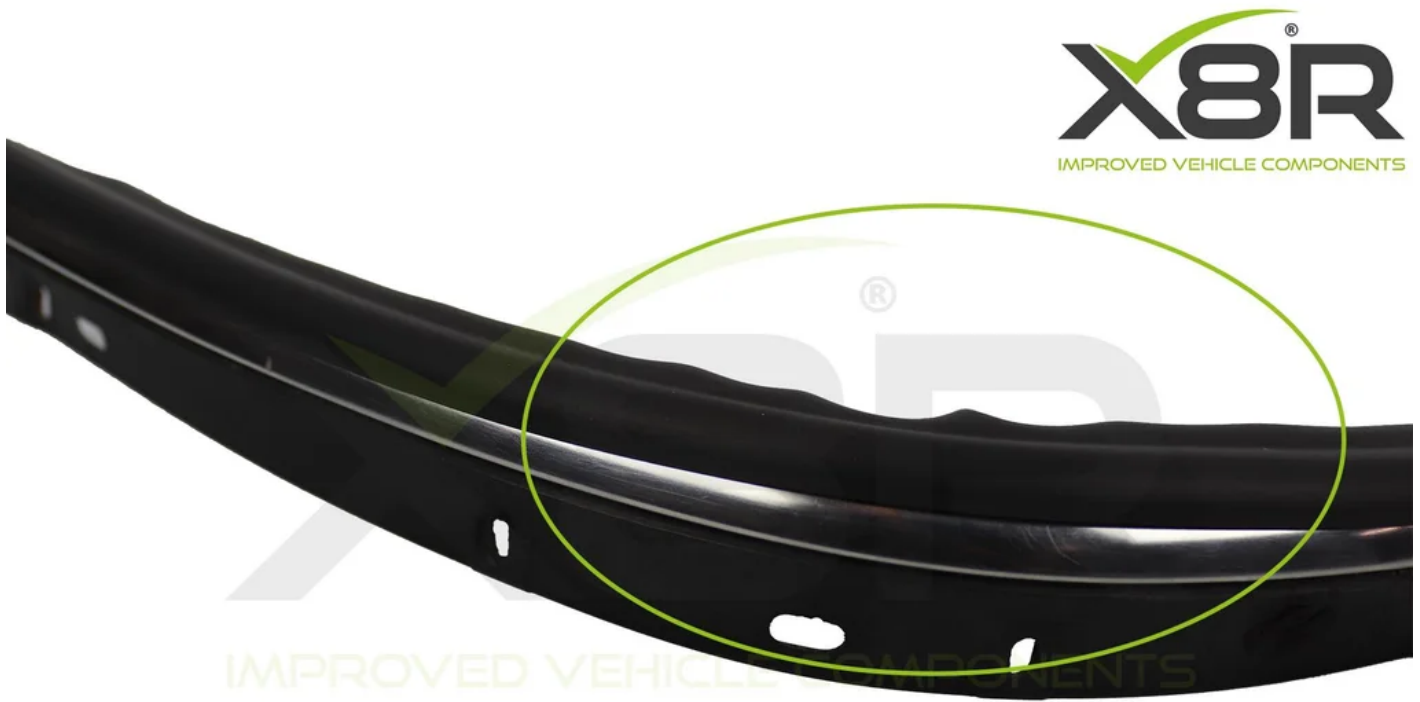
## Step 9:

Please note that the trim may appear to wrinkle/buckle around the corner. This is completely normal as the trim is extruded and not moulded. When the chrome trims are installed onto the canvas roof the appearance of wrinkling will decrease.

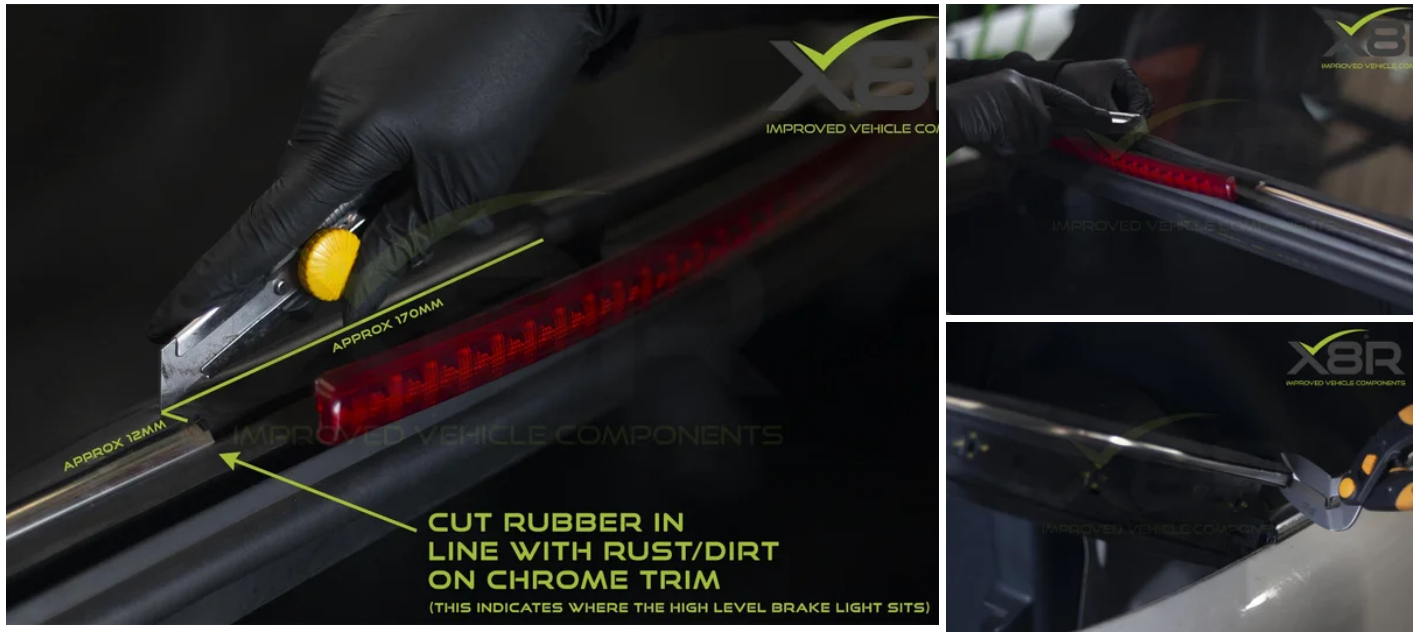
## Step 10:

Insert the trims back into place on the canvas roof. Press the high level brake light back into position and mark where the rubber trim needs to be cut out. See the approximate measurements in the photo.

Cut the rubber trims directly in the middle (where they meet behind the high level brake light).

Cut any excess rubber from the ends of the chrome trim.

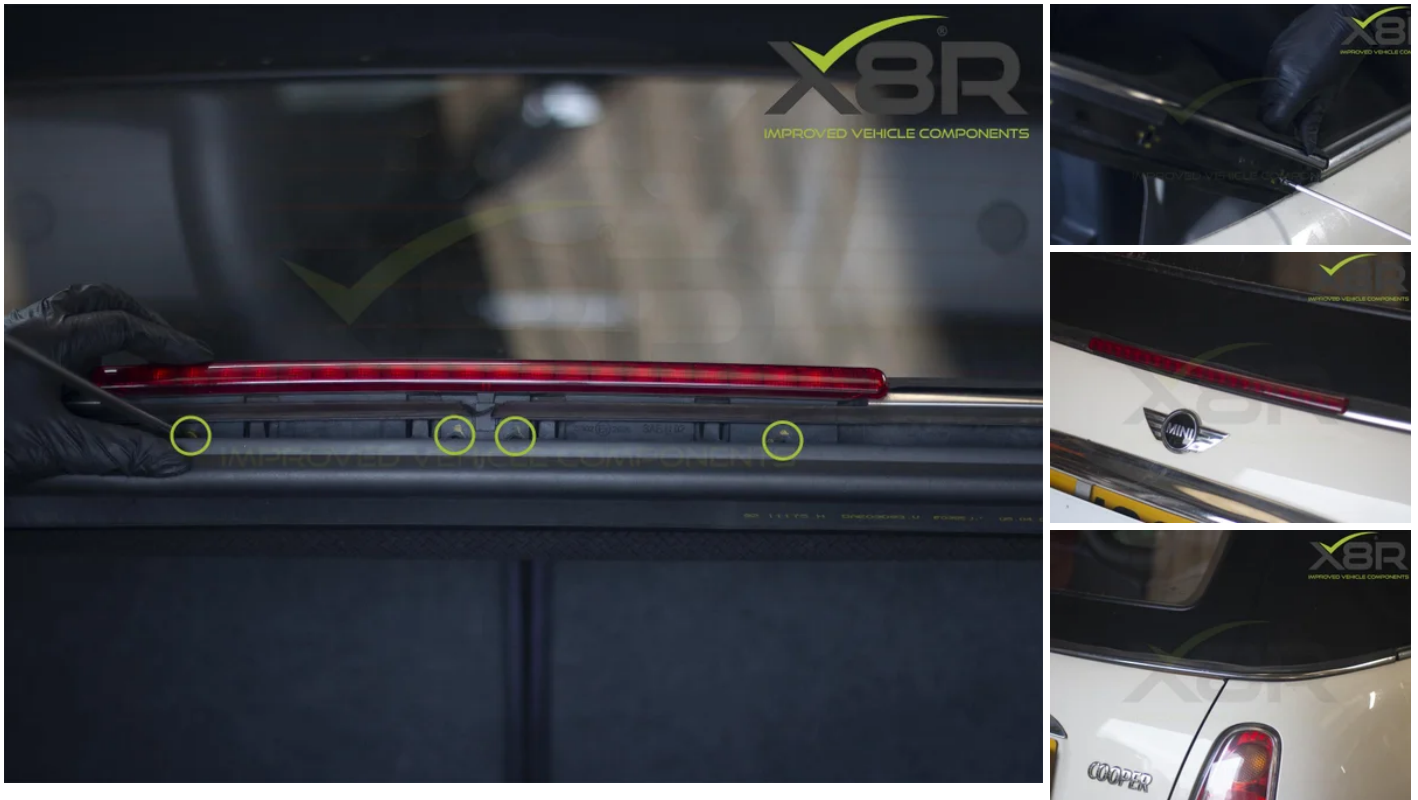
## Step 11:

Fit the new screws using a 2.5mm Allen key or Hex Bit. Be aware that the screws with the longer threads fit into the high level brake light.
