Pierburg Intake Inlet Manifold Swirl Flap Blank Blanking Removal Repair Kit De-flap Kit Caps Delete Bungs

Intro: Pierburg Intake Inlet Manifold Swirl Flap Blank Blanking Removal Repair Kit De-flap Kit Caps Delete Bungs **The Problem**

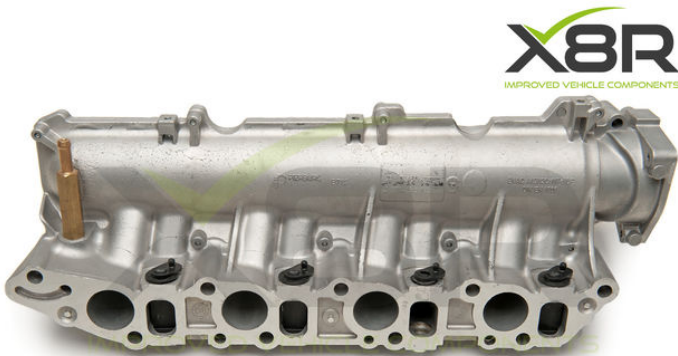
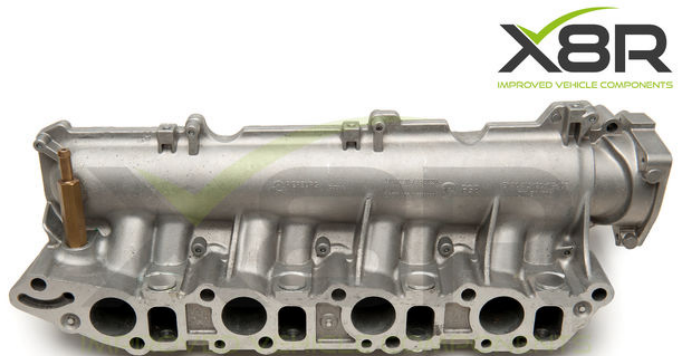
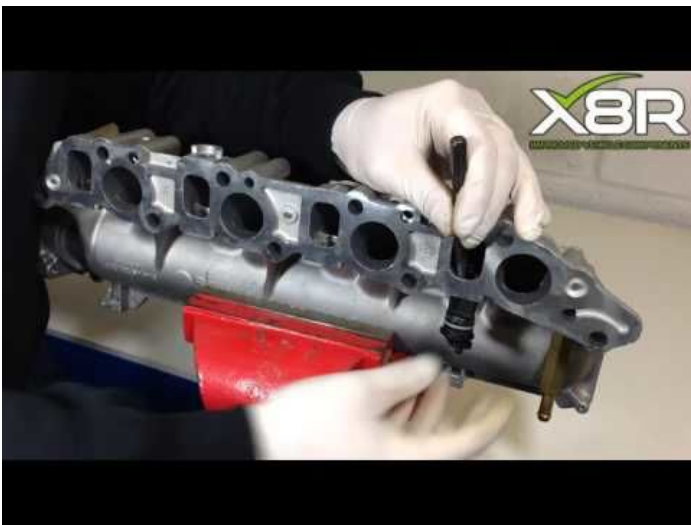
4X Large cnc machined billet aluminium blanks (fitted with high quality Viton O-ring)

1X Small cnc machined billet aluminium blank (fitted with high quality Viton O-ring)

1X Adhesive to secure the blanks

Our unique design kit allows you to blank off the swirl flaps on your original intake manifold resolving swirl flap faults permanently. Our blanks are precision engineered from billet aluminium and are fitted with a Viton O ring to ensure a good seal, a far better alternative to pressed parts which can fail to seal.

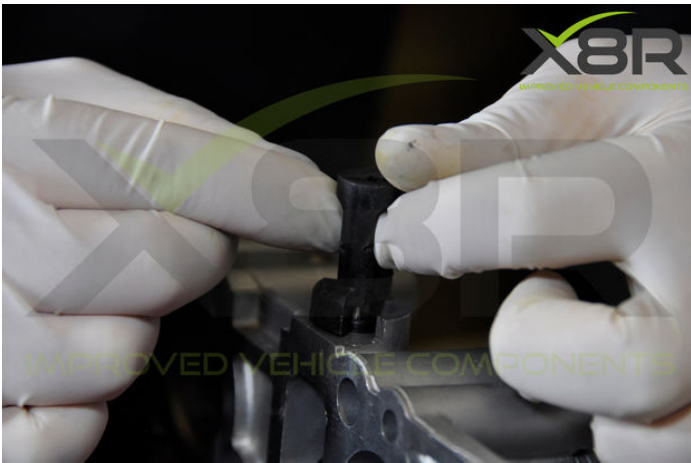
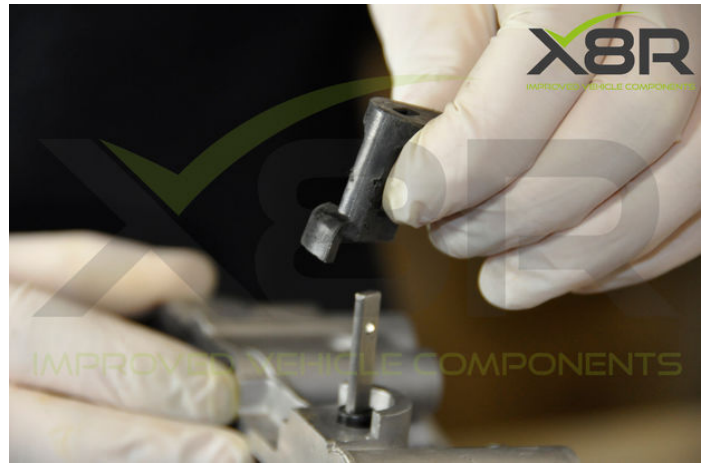
Step 1: Remove the swirl flap actuator arm

- On the the underside of the intake manifold pry back the two tabs as shown and lift off the plastic part.

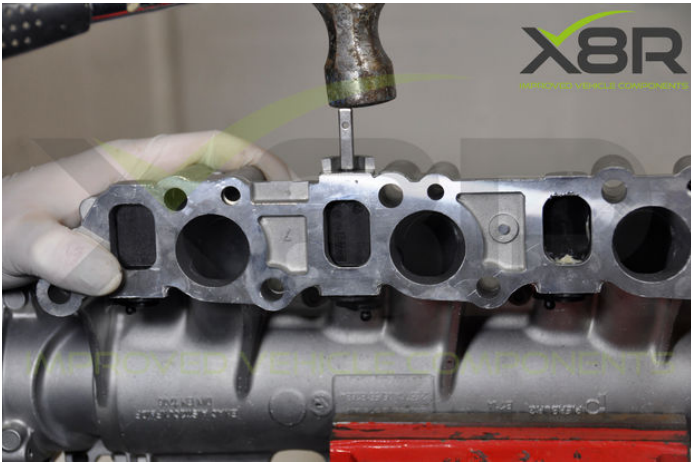
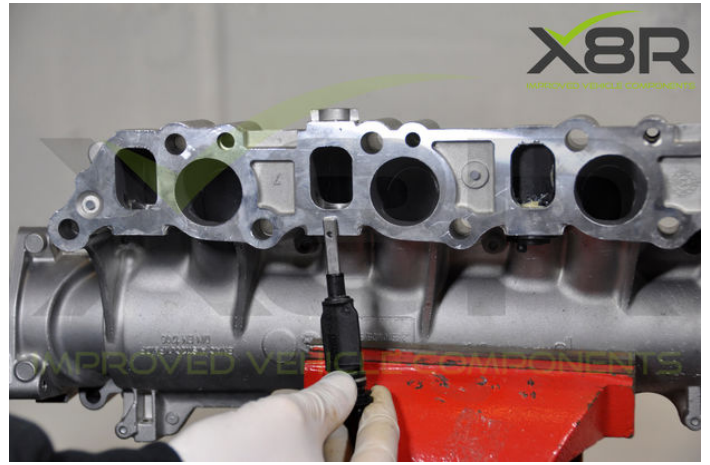
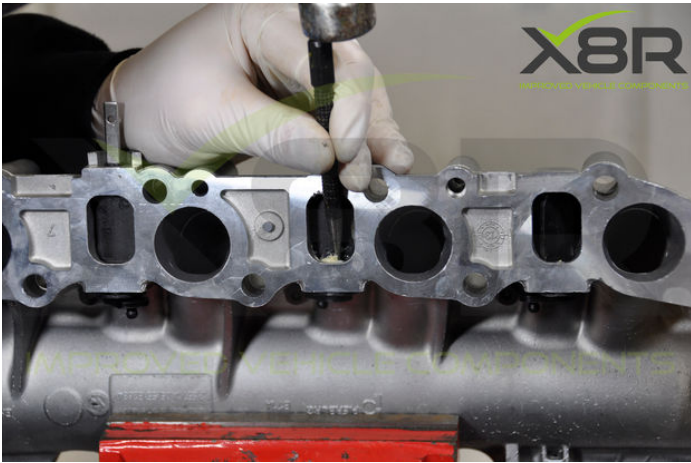
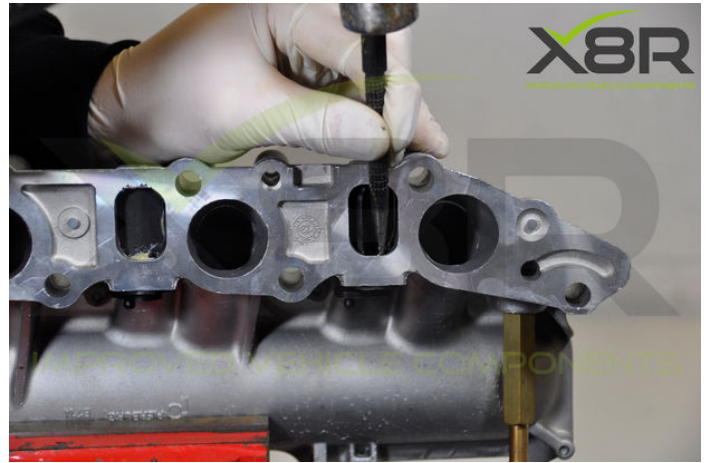
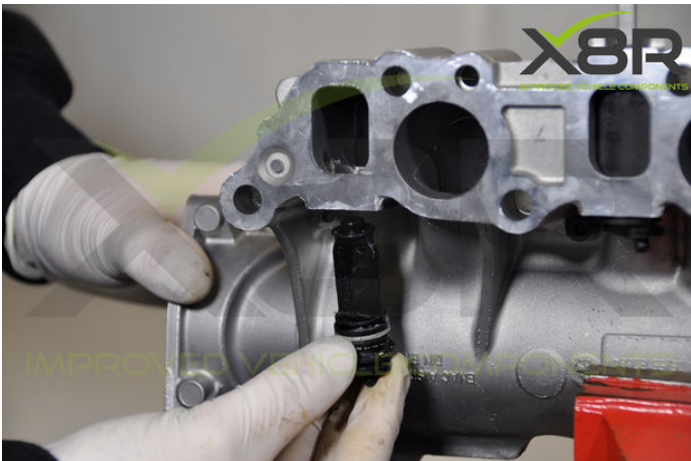
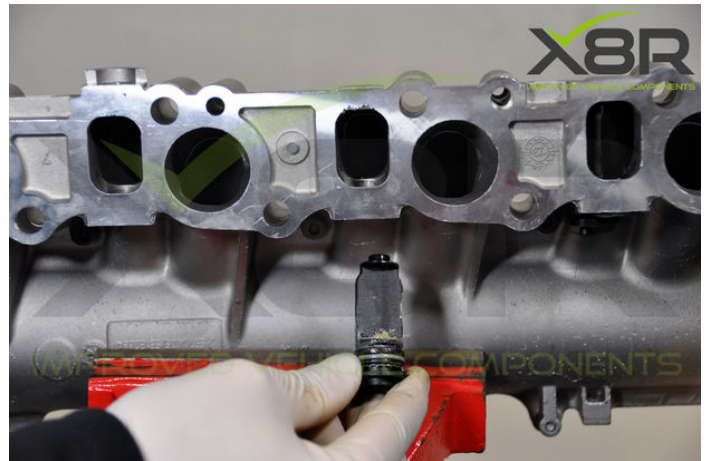
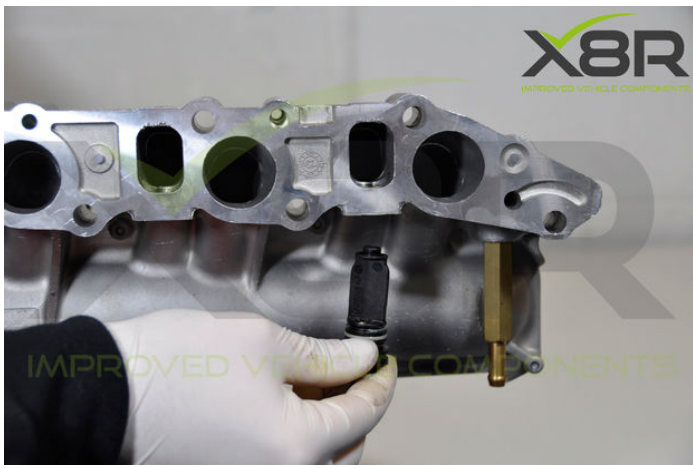
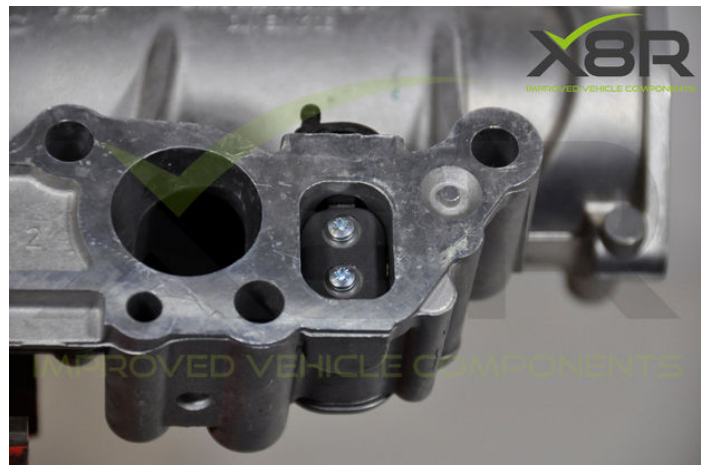
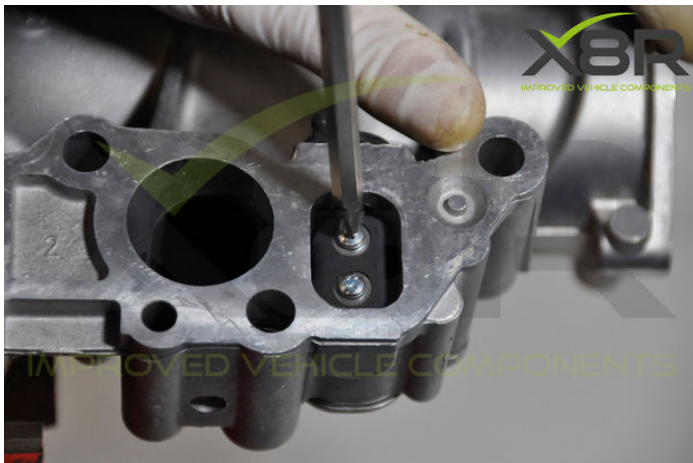
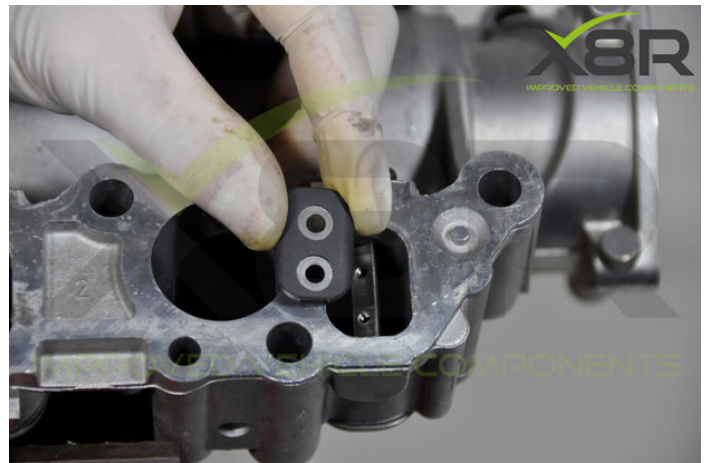
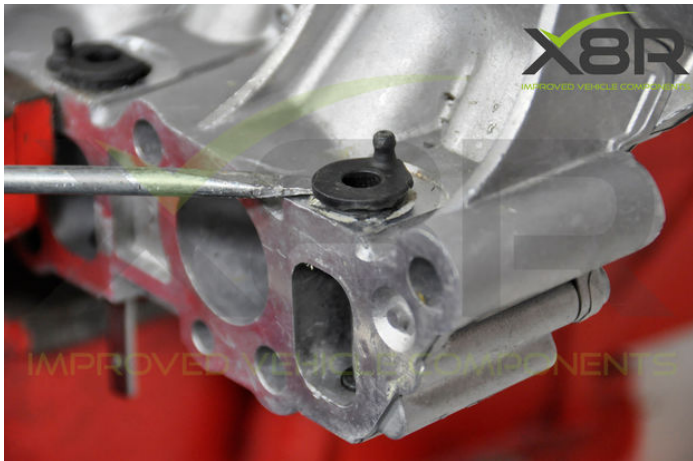
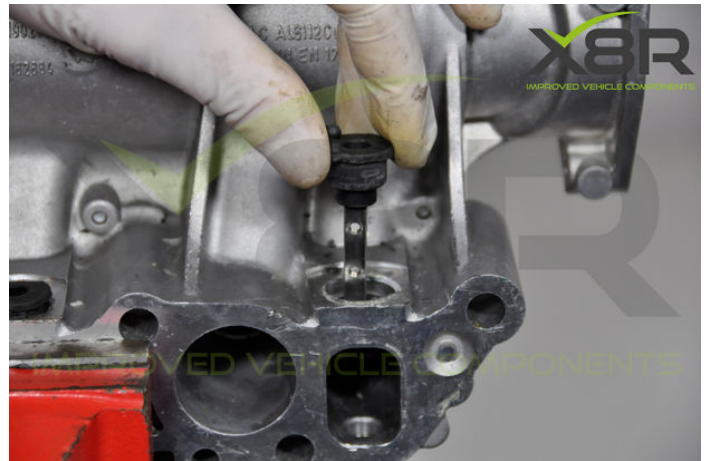
Step 2: Remove the swirl flaps

Newer design intake manifolds with part numbers: 55210202, 55210201, 2.03462.03, 2.03462.02:

- Using a small punch, tap out the old swirls - you may have to tap out the swirls in different positions to allow the swirls to be removed from the manifold.

Older design intake manifolds with part numbers: 55206459, 55190238, 55194739, 55206460, 2.03462.01, 2.03462.00:

- Unscrew the two screws on the flap and remove the flap.
- To remove the remnants of the swirl flap insert a pry tool or flat headed screwdriver under the outer part of the swirl flap and lift up.
- If the swirl doesn't want to lift out; twist the swirl and try again.
- Repeat process for all swirl flaps.
- Clean the inlet manifold of all soot/oil making sure the 5 holes are clean and free of grease.

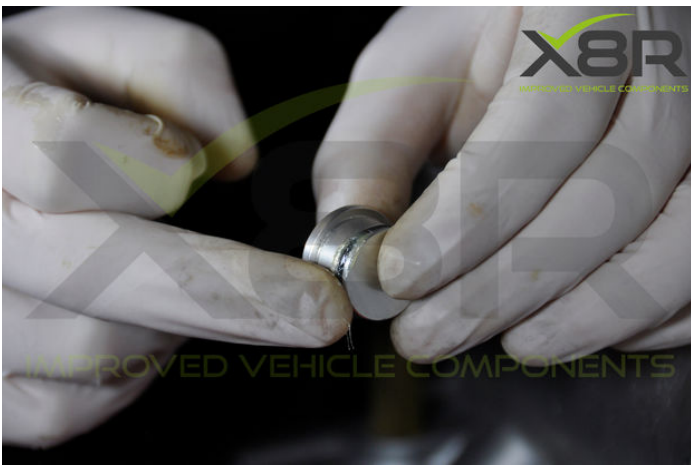
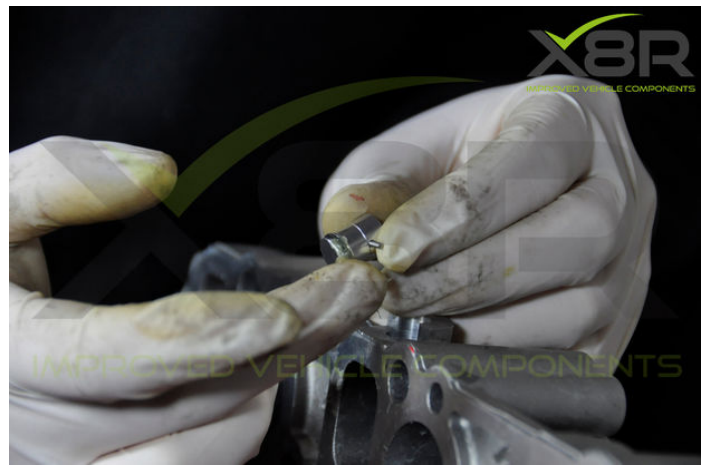
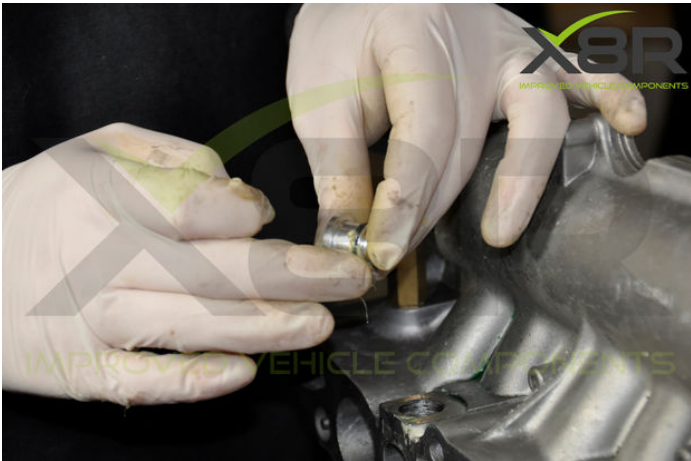
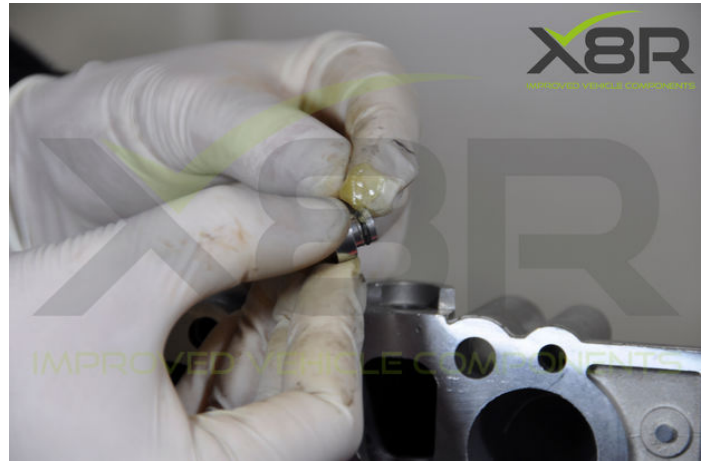
Step 3: Test fit swirl flap blanks before fitting

- Before gluing the swirl blanks; apply a small amount of grease to the o-ring on the blanks and test fit. The O-rings are designed to be a tight fit (based on normal wear) take care not to damage the o-ring seals. Do not force in but ease in a little at a time, varying the angle to ensure the o-ring seals and doesn't bind.

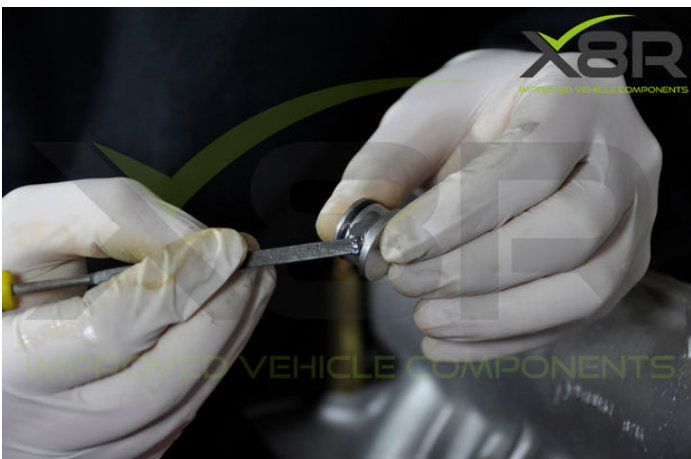
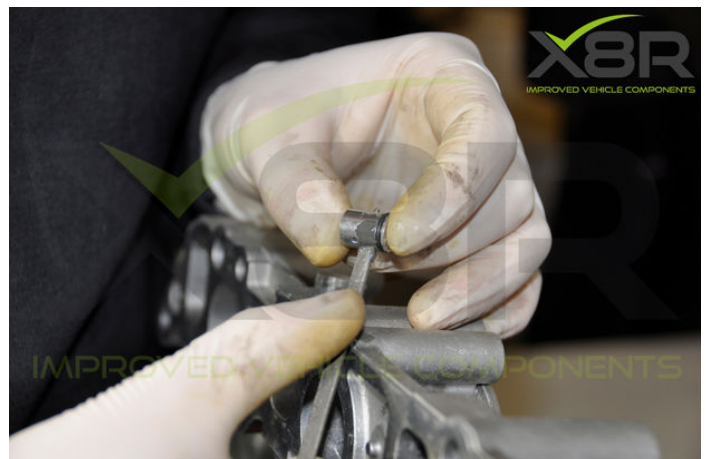
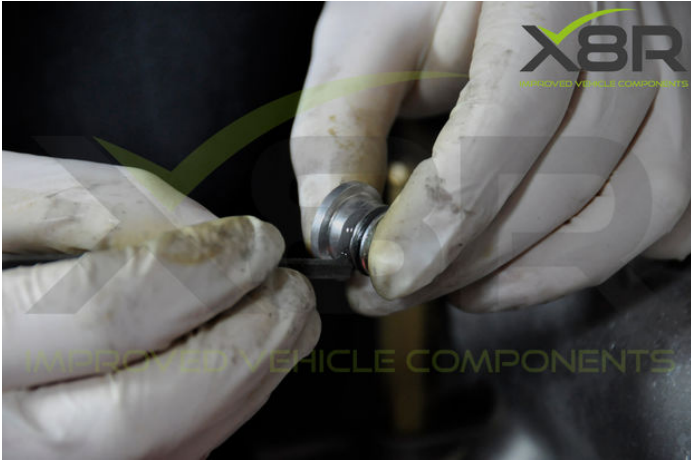
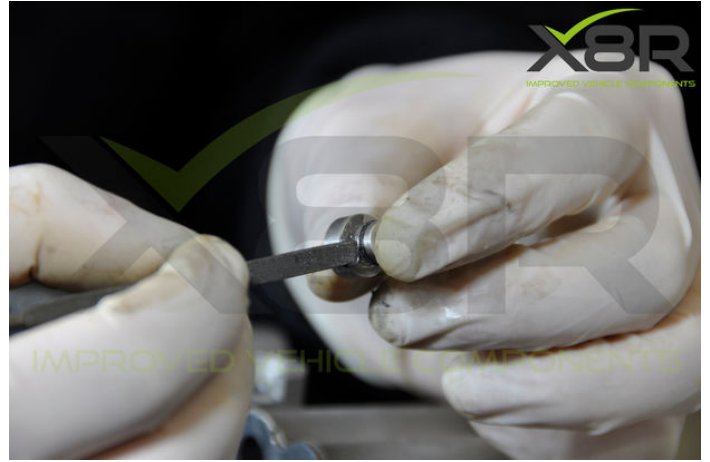
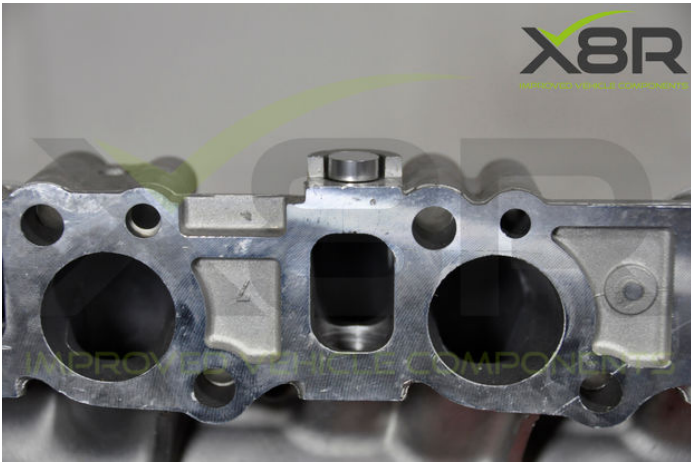
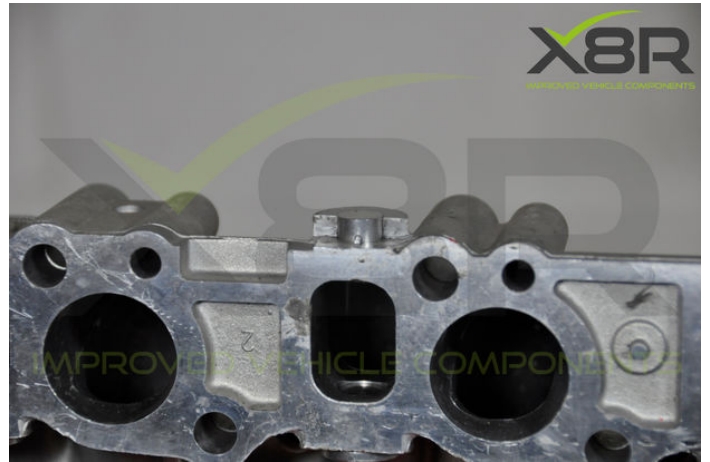
Step 4: Glue the blanks in position

- Once you are satisfied the o-rings have been shaped and are sealing correctly. Using the adhesive supplied apply evenly around the blanks, keeping to the metal surface area of the blanks and avoiding the o-ring seal.
- Press the blanks into the holes.
- Please follow the adhesive instructions included with our product for mixing and curing times.
- When refitting the intake manifold the flap actuator motor should remain fitted as well as the electrical connection but the lever arm should be disconnected. This enables the ECU to identify that the motor is functioning correctly and should not cause any error lights to show up on the vehicles dashboard.
